Service Information

Date: John Deere Waterloo Works

UPPER PTO IDLER SHAFT - BORE RECLAIM SPECS 4640 and 4840 PST Tractors

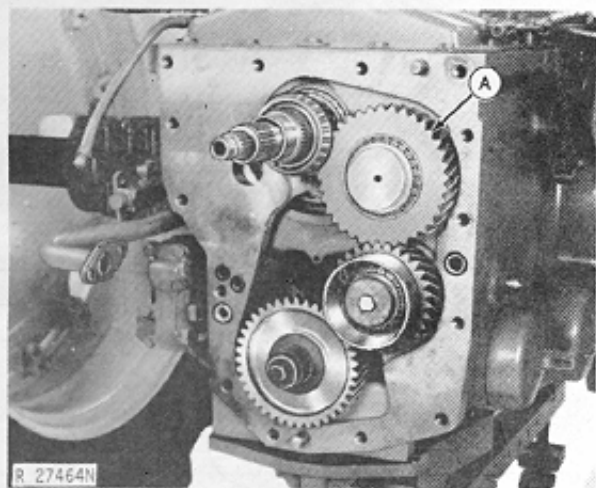
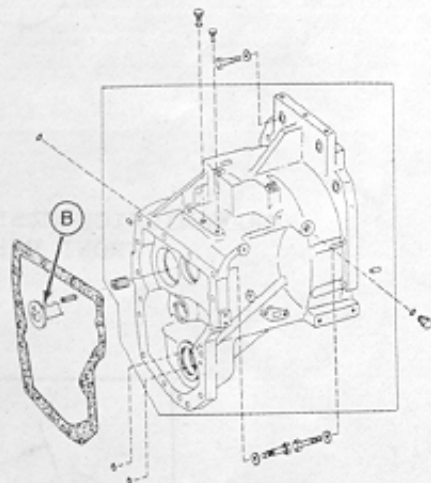
Depending on tolerances and PTO power usage, the upper PTO idler shaft (A) can rotate and wear into the clutch housing and/or transmission case. This shaft "creep", over an extended period of time, will cause improper gear contact in the PTO power train and eventual gear failure.

On 4640 (1000 - 20584) and 4840 (1000 - 11689), the R64249 Idler Shaft will sub to R72051 Shaft, R72052 Deflector, and 34H348 Spring Pin. The deflector (B) was installed on 4840 PST Tractors as a running change. Its purpose is to catch and route oil to lube the PTO idler gears and shafts. Tractors 4640 (1000 - 20584) and 4840 (1000 - 11689) are not equipped with this feature. They did, however, utilize a retainer on the idler shaft to

Dealers attempting to sleeve the respective bores need original bore dimensions and reference points. Reference Page 2 for original dimensions and SIB R85-50-16 for general machining guidelines.

distribute oil. Tractors with an upper PTO idler shaft failure are instructed to order the new shaft and deflector for installation. It is important to note that the PTO idler shafts can normally be a slip fit of about 0.03 - 0.05 mm (0.001 - 0.002 in.) in the clutch housing and transmission case.
