Autopilot

AUTOMATED STEERING SYSTEM

Version 4.00
Revision A
September 2016

This is the October 2016 release (Revision A) of the *Autopilot Automated Steering System Troubleshooting Guide*. It applies to version 4.00 of the NextSwath Vehicle Integration End-of-Row Turn Technology.

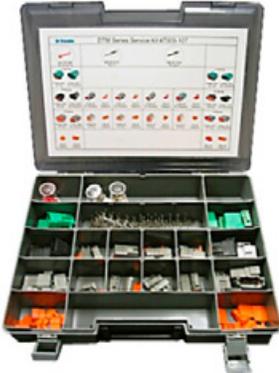
Name	Part number	Image
Trimble Deutsch DTM service kit	7005-107

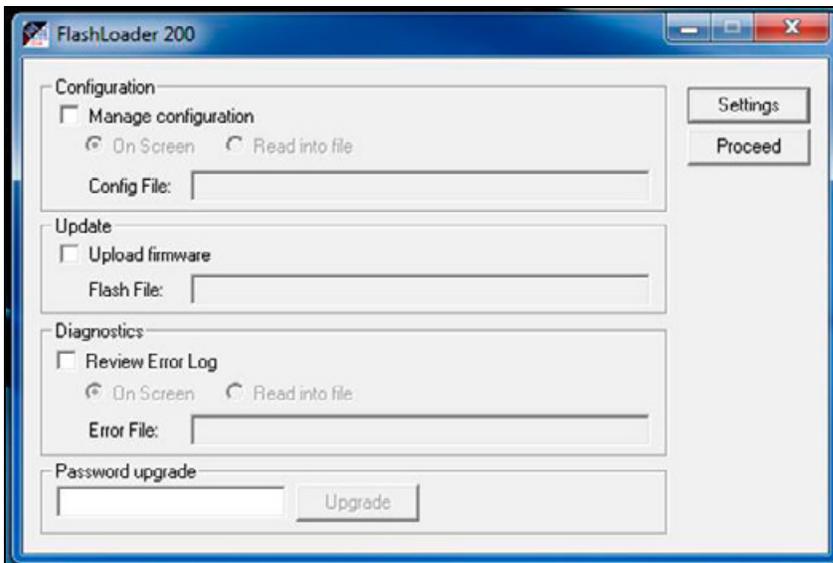
1. Run the Flashloader 200 utility and then click **Settings**:

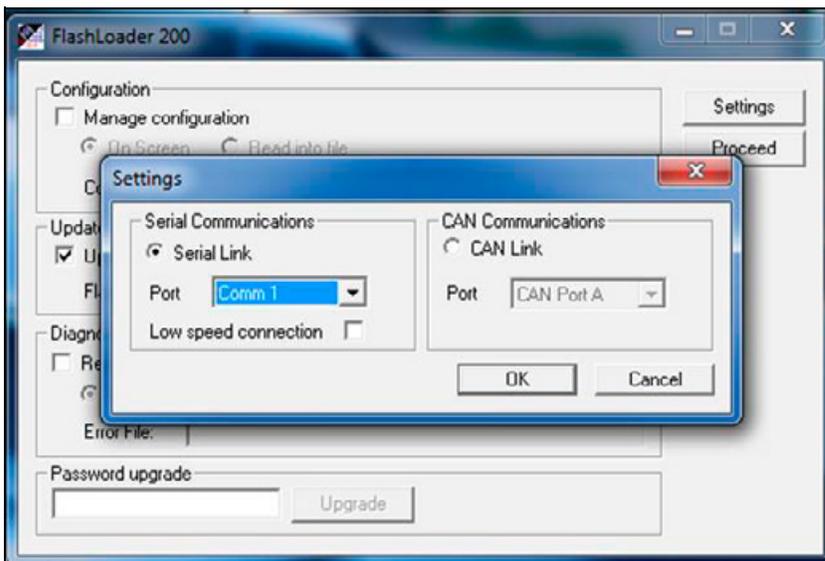
2. Select the required *Serial Communications* link and then click **OK**:

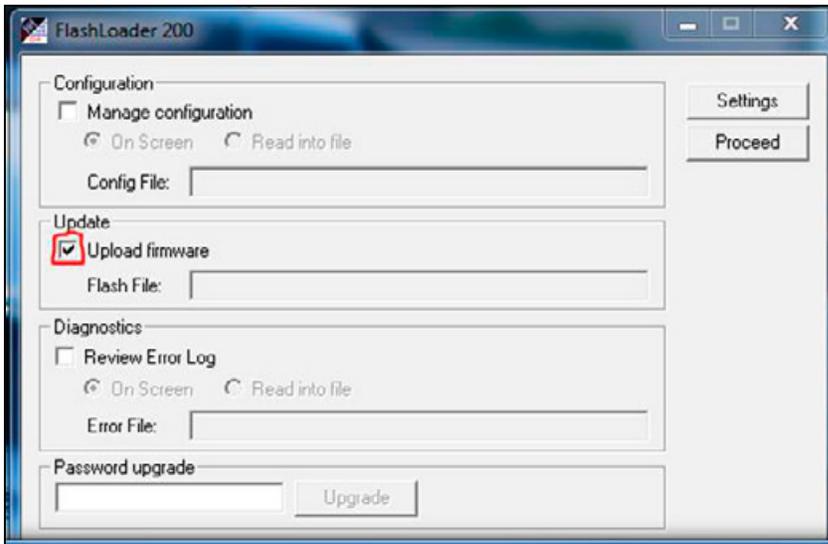
3. Select the *Upload Firmware* checkbox:

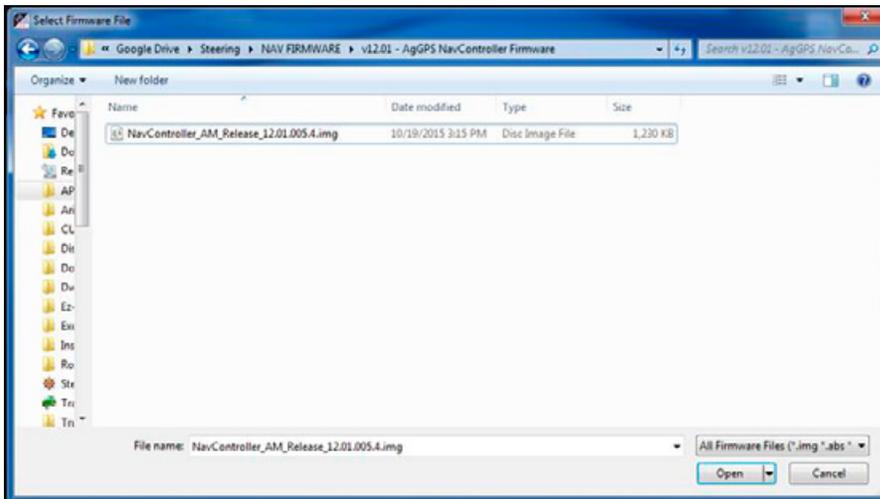
4. Browse to the desired NavController Firmware .img file and then click **Open**:

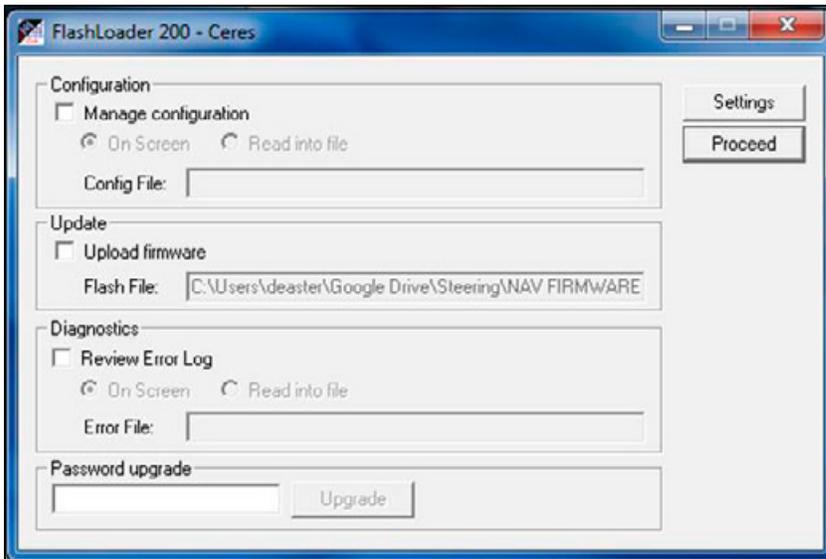
5. Click **Proceed**:

- *Querying*: This should go quickly (~5 seconds). If the utility stops working, there is a serial communication problem.
- *Uploading New Firmware*: It takes approximately 1–3 minutes for the firmware to be uploaded to the controller.
- *Erasing Program Space*: This should go quickly (~10-15 seconds).
- *Programming New Firmware*: This should go relatively quickly (~ 30 seconds).

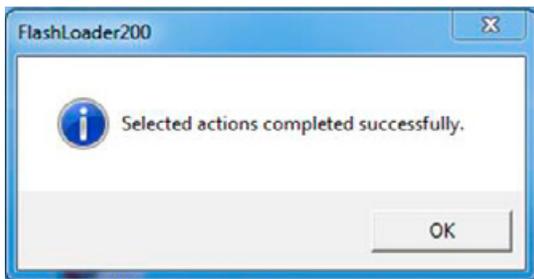
When complete, a message appears to confirm that the action was completed successfully:

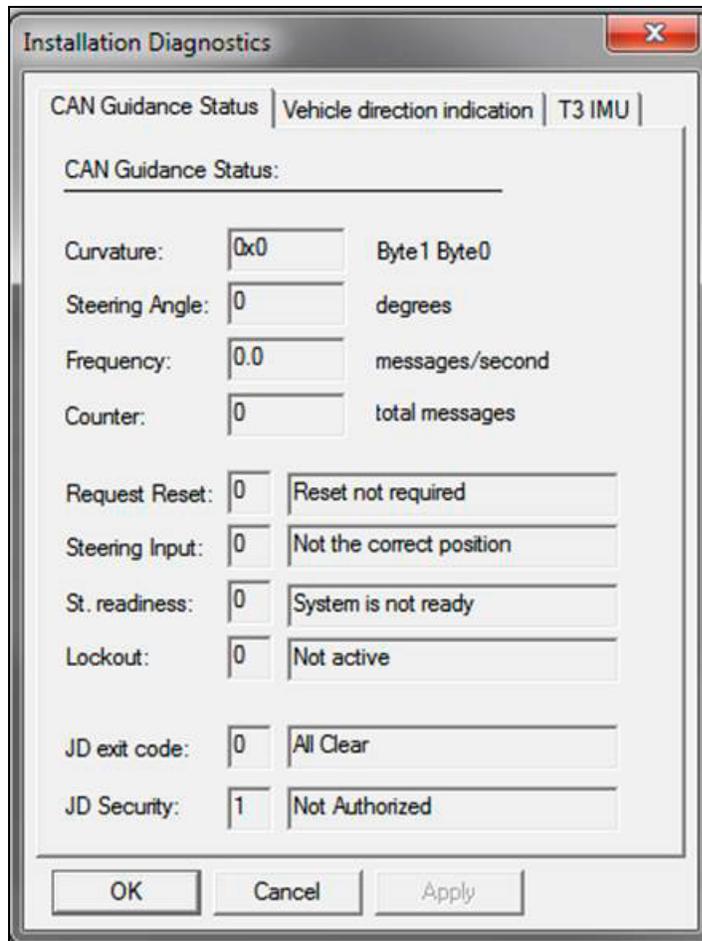
For vehicles that use the CAN interface for the NavController to send curvature commands to a closed loop controller on the machine, the Autopilot Toolbox utility has a *Can Diagnostics* page to help troubleshoot connection or state errors.

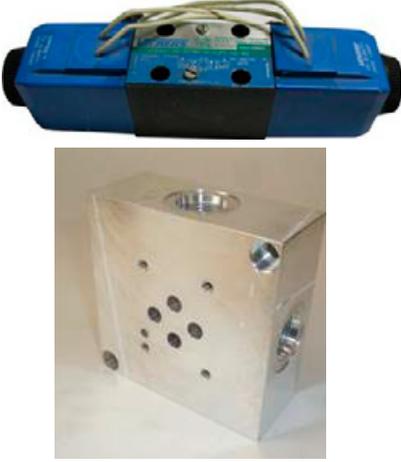
Valve	Image	Description
<p>D03 19 LPM PWM closed center proportional valve and subplate</p>

<p>Trimble P/N 49903 Manufacturer P/N KDG4V-3S-2C19N-M-KU-P1-U-H5-60</p> <p>This is a 19 LPM PWM valve that is closed center when the spool is in the neutral position. Meter-in and meter-out flow control. It is used in applications where there is a constant pressure supply. The aluminum sub-plate serves only as a mount with direct ports to P, T, A, and B.</p>
<p>D03 8 LPM PWM proportional valve</p>

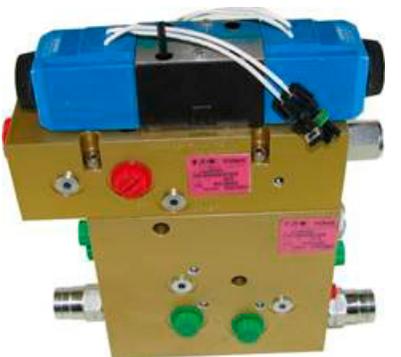
<p>Trimble P/N 67987 Manufacturer P/N KDG4V-3S33C08A-MKUP1H5-60EN692</p> <p>This valve is an 8 LPM PWM valve that has the A and B ports orificed to tank when the spool is in the neutral position (motor spool). Meter-in only flow control. It is used in both Open Center and Closed Center applications.</p>
<p>D03 8 LPM proportional valve with H3 manifold open-center configuration</p>

<p>Trimble P/N 89017</p> <p>This valve/manifold combination is used on smaller open center vehicles. The valve is P/N 67987; an 8LPM PWM valve. Counterbalance valves are used for flow control through the A and B ports.</p>

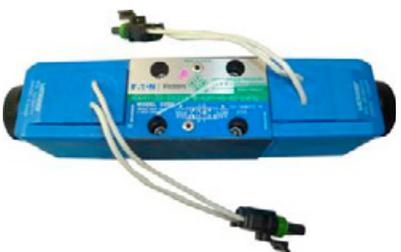
<p>D03 22 LPM PWM proportional valve</p>

<p>Trimble: P/N 67988 Manufacturer: P/N KDG4V-3S33C22A-MKUP1H5-60EN692</p> <p>This valve is a 22 LPM PWM valve that has the A and B ports orificed to tank when the spool is in the neutral position (motor spool). Meter-in only flow control. It is used in both Open Center and Closed Center applications.</p>

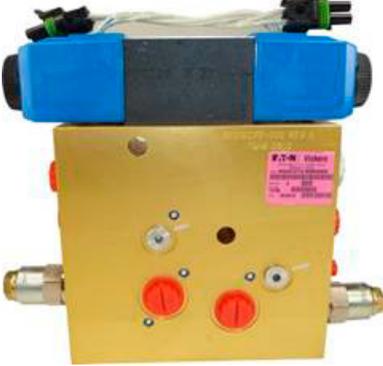
Valve	Image	Description
<p>D03 22 LPM PWM proportional valve with H3 closed-center configuration</p>

<p>Trimble P/N 89018</p> <p>This valve/manifold combination is used in medium-sized vehicles for closed-center load sensing applications.</p> <p>LS1 and LS2 have a pilot to shift the cartridge between them.</p> <p>The valve is P/N 67988; a 22 LPM PWM valve.</p>
<p>D03 22 LPM PWM proportional valve with H3 open-center configuration</p>

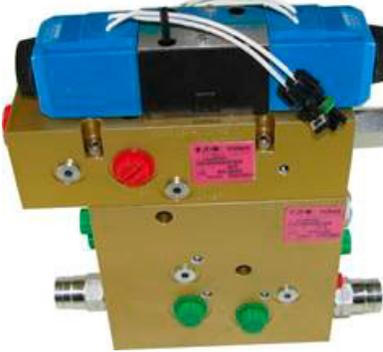
<p>Trimble P/N 89020</p> <p>This valve/manifold combination is used on medium open-center vehicles. The valve is P/N 67988, a 22LPM PWM valve.</p> <p>Counterbalance valves are used for flow control through the A and B ports.</p>
<p>D05 60 LPM PWM proportional valve</p>

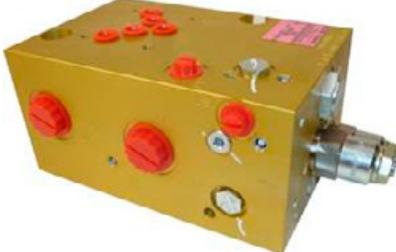
<p>D05 Manifold</p>

<p>Trimble P/N 89019</p> <p>This manifold is used with the D05 PWM valve.</p> <p>It has counterbalance isolation and is configured for closed-center use with a shuttle between LS1 and LS2.</p>
<p>60 LPM PWM proportional valve and manifold</p>

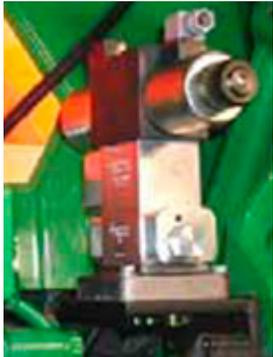
<p>Trimble P/N 0720-4900</p> <p>This valve/manifold combination is used on the John Deere ILS machines.</p> <p>It has a 60 LPM valve with D05 sub-plate, shuttle assembly, and pilot-operated checks.</p>

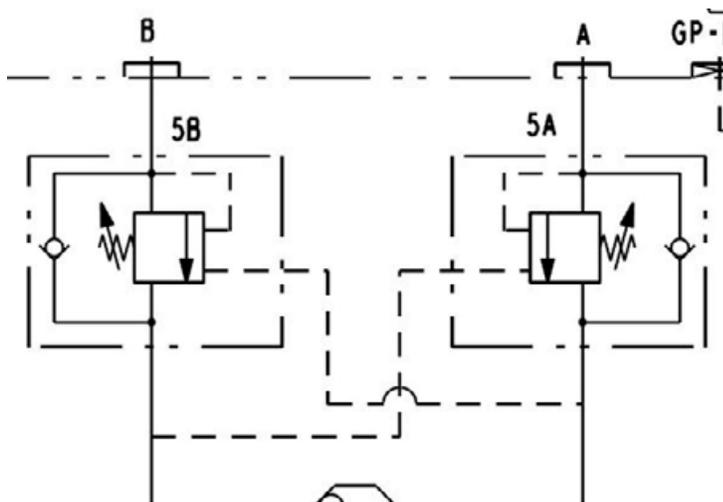
The Autopilot system uses counterbalance valves in a dual configuration to isolate either the H3 or the handpump from the steering circuit when the other actuator is in use. In this case they are cross piloted so that flow out of one port (A) opens return flow for the other (B).

Note that the check valve allows for free flow out of H3 with no requirements to overcome the pilot pressure. The pilot pressure is what can be adjusted (shown by the arrow with the spring through it in the image above) on the older versions of H3. The new versions of H3 do not allow for adjustment. This is set to open at a specific pressure and should not be adjusted. The function of the return port being piloted open based on the pressure at the load port facilitates a metering function that controls the return flow based on the load pressure. This effectively provides the meter-out function as the valve spool does not employ a meter-out capability. The CBV cartridges have a secondary function: To provide a work port pressure relief function. If the work port (cylinder line) exceeds the set pressure of the CBV, the CBV will open and allow oil to flow into the H3, backflow through the proportional valve, and out to tank.

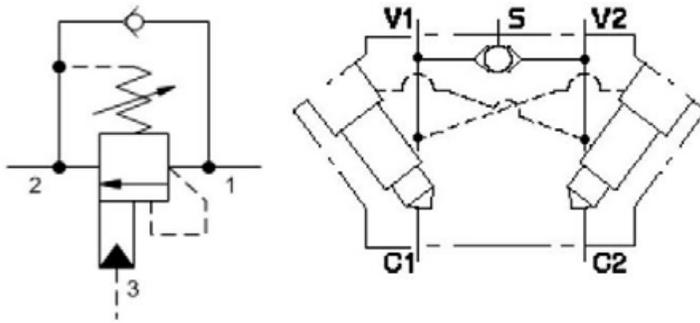
The shuttle valve in the DCBV is in an alternate location to the pressure transducer used for manual over-ride.

Remember: C goes to cylinder, V goes to valve (in this case, the hand pump) and **do not touch the pressure adjustment!**

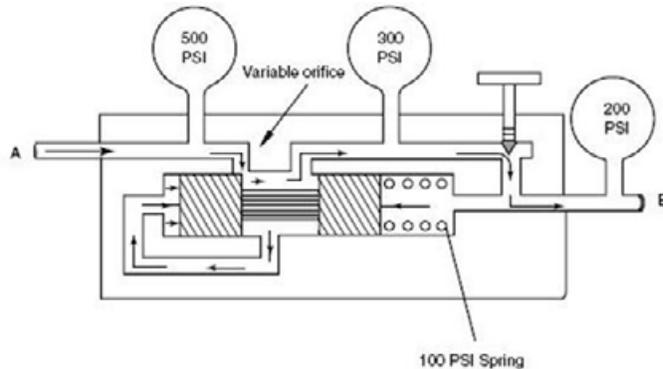
A pressure-compensated flow-control valve has a provision for maintaining the pressure drop across the proportional valve as the load pressure and supply pressures vary. This is used to control speed of actuation, that is the back and forth wheel movement.

When the H3 valve is the only component providing the load sense signal to the priority valve, the pressure supplied to the spool is what the H3 valve has called for. But when additional items are on the circuit (SCVs, hand pumps, brakes, and so on), other items may be calling for a higher pressure than that needed by the H3 valve.

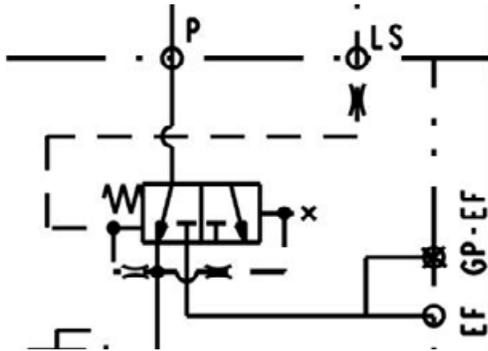
When manual steering, flow goes right through the H3, out the EF line, to the hand pump. When the Autopilot system is engaged, the LS pressure in H3 causes the PRFD to divert some or all of the pump flow to H3. Any flow not needed by H3 is directed to the EF port.

PFRD cartridges are similar to the pressure compensation cartridge discussed earlier in that they maintain a pressure across the H3 spool and also control the flow rate to the priority (H3) and excess flow (EF) port. All flow from the pump goes to H3 or out the EF port.

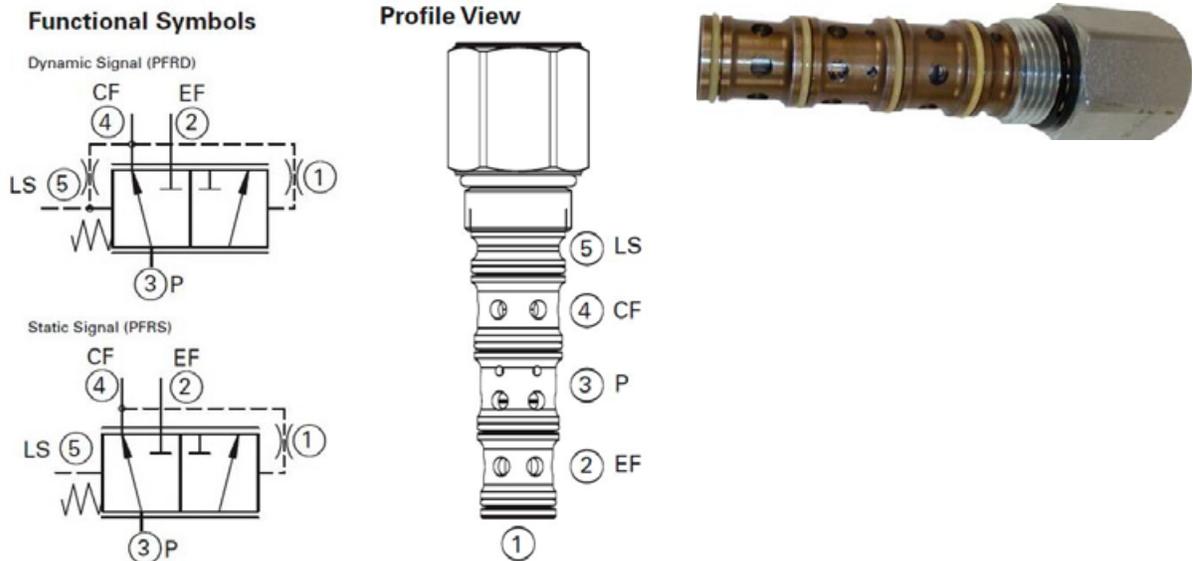
Generally, the EF port returns oil to the tank via several other open-center components. Trimble uses two variations: 110psi and 145 psi, like the P-Comp valve, and these are the pressures maintained across the H3 spool. The 145 psi cartridge will flow more oil through the H3 valve than the 110 psi cartridge.

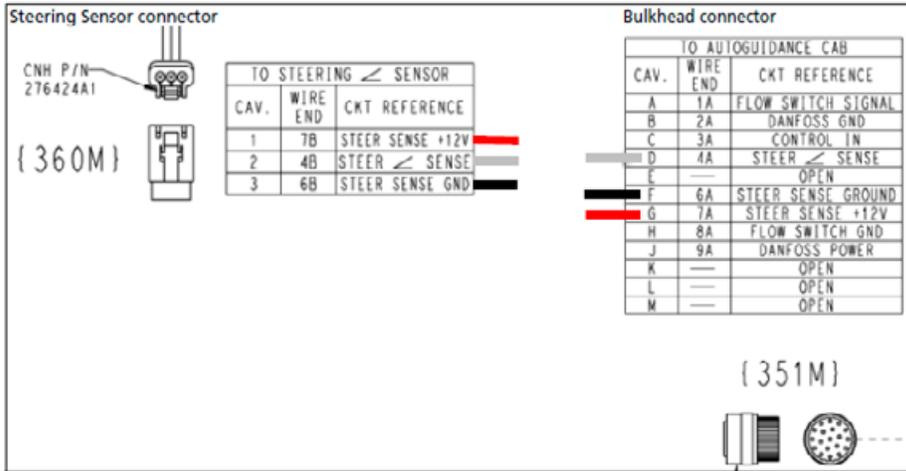
Wire ID	Bulkhead	Sensor cavity	Wire color	Description
4	D	2	White	Sensor signal
6	F	3	Black	Ground
7	G	1	Red	+12 V

Wire information is shown below:

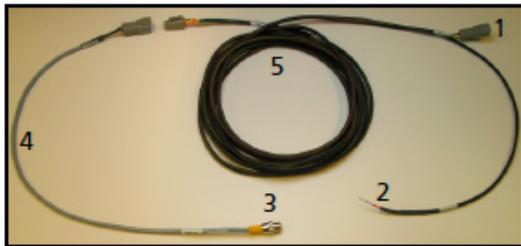
The following figure shows the AutoSense™ steering device harness:

Item	Description
1	P-6 connector
2	Power connector
3	AutoSense connector
4	Jumper cable (P/N 57560)
5	AutoSense steering cable (P/N 57885)

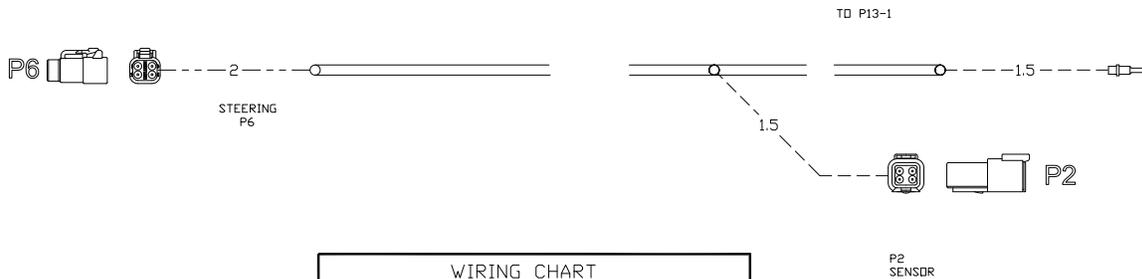
AutoSense steering cable (P/N 57885) schematic:

WIRING CHART					
WIRE ID#	CONN-TERM	CONN-TERM	WIRE COLOR	WIRE SIZE	DESCRIPTION
1	P6-1	P2-1	BR	18	STEERING SENSOR 5V+ IN
2	P6-2	P2-2	RD/WH	18	STEERING SENSOR 5V- IN
3	P6-3	ITEM 6	DR	18	STEERING SENSOR 12V+
4	P6-4	P2-4	YW	18	STEERING SENSOR GND

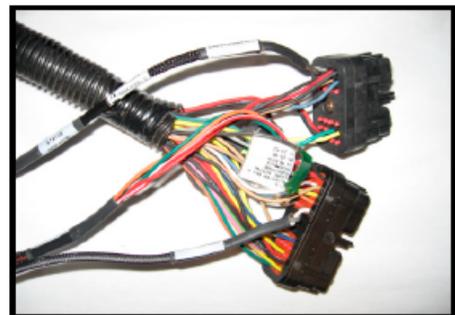
To install the EZ-Guide 500 system on a hybrid system, you require the EZ-Guide 500- to-hybrid Autopilot cable:

1. Locate the Autopilot controller main and auxiliary harnesses.

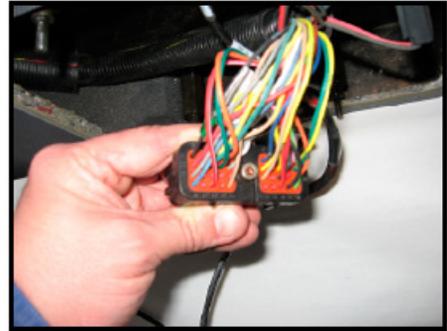
2. On the 40-pin main harness, identify the PPS wire. It is in position 21.

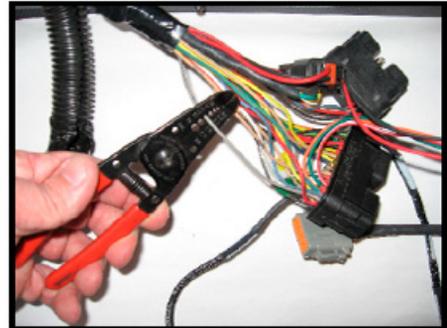
3. Cut the PPS wire, as shown. Ensure that you bisect the wire between the wire loom and the connector.

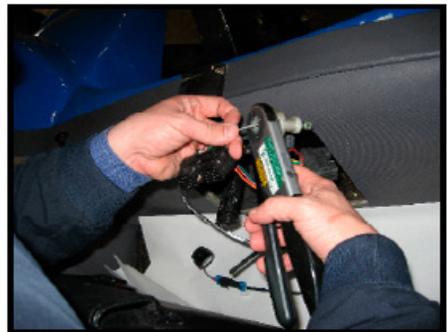
4. Strip the cut wire ends.

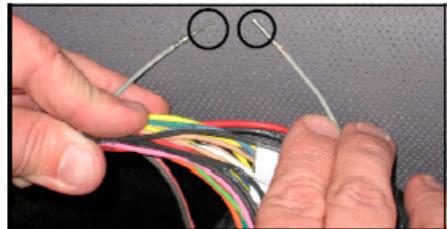
5. Add Deutsch connector pins to the wires.

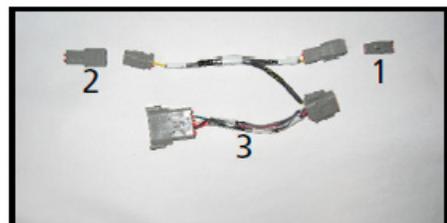
6. Attach connectors to the wires:
 - a. Add a Deutsch-in connector P5 cap (1) to the wire end that connects to the Autopilot controller.
 - b. Add a Deutsch-out connector S6 cap (2) to the Autopilot harness end. Insert the Deutsch pins into pin 1 on each cap.

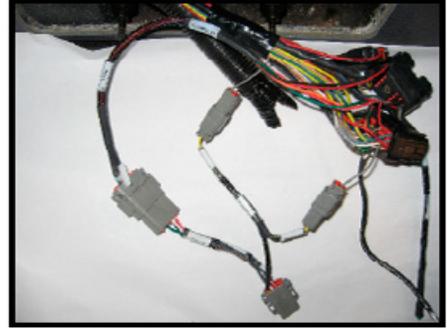
7. Connect the Deutsch connectors to the two appropriate connectors on the EZ-Guide 500-to-hybrid Autopilot cable (P/N 62700) (3).

8. Connect the P4 connector on the cable to the P4 cable supplied in the hybrid completion kit (ZTN 56694 00).

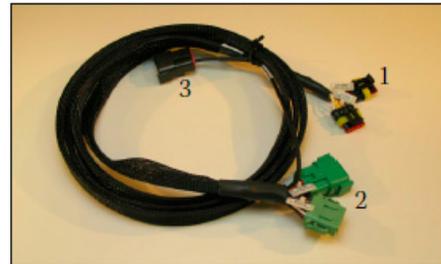
Item	Description
1	J1A and J2A steering encoder jumper
2	P5A and P5B vehicle sensors
3	P13 spare sensor

4. Disconnect and then reconnect the J1A and J2A jumpers to the tractor harness.
5. If the fault continues, install new cables between the NavController II / NavController III and the John Deere AutoTrac. See the figure and table on the following page.

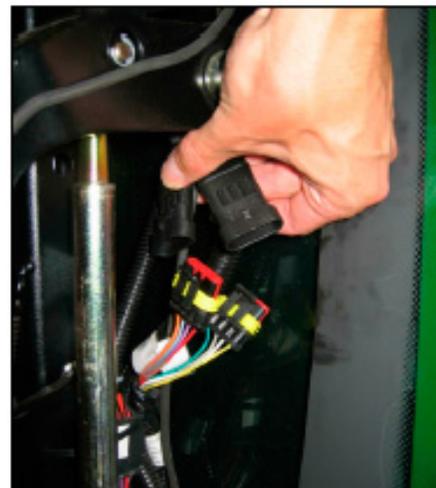
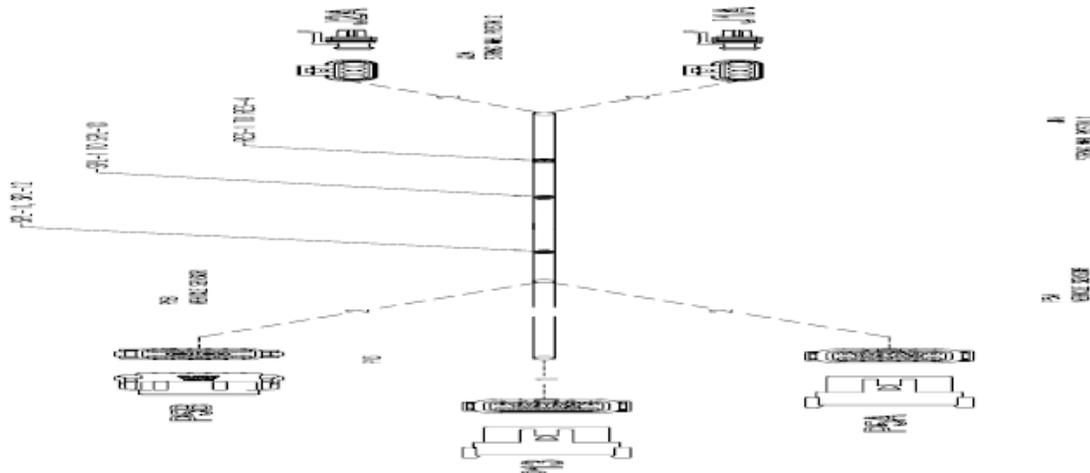
Cabling diagram

The table shows the wiring for the NavController II / /NavController III and John Deere AutoTrac

Wire ID #	Conn-term	Conn-term	Wire		Description
			Color	Size	
1A	J1A-1	SPL-1	WH	18	+5 V OUT
1B	SPL-1	RES-1	WH	18	+5 V OUT
1C	SPL-1	SPL-3	WH	18	+5 V OUT
1D	SPL-3	RES-2	WH	18	+5 V OUT
1E	SPL-3	SPL-9	WH	18	+5 V OUT
1F	SPL-9	SPL-11	WH	18	+5 V OUT
2A	J1A-2	SPL-2	YW	18	IN_5V_6_ADT+
2B	SPL-2	RES-1	YW	18	IN_5V_6_ADT+
2C	SPL-2	P5A-4	YW	18	IN_5V_6_ADT+
3A	J1A-3	SPL-4	OR	18	IN_5V_5_ADT-
3B	SPL-4	RES-2	OR	18	IN_5V_5_ADT-
3C	SPL-4	P5A-3	OR	18	IN_5V_5_ADT-
4A	J1A-4	SPL-10	BK	18	GND_SIG
4B	SPL-10	SPL-12	BK	18	GND_SIG
4C	SPL-12	P5A-11	BK	18	GND_SIG
5A	J2A-1	SPL-5	GY	18	
5B	SPL-5	RES-3	GY	18	
5C	SPL-5	SPL-7	GY	18	
5D	SPL-7	RES-4	GY	18	
5E	SPL-7	SPL-9	GY	18	
6A	J2A-2	SPL-6	BU	18	IN_5V_9_ADT-
6B	SPL-6	RES-3	BU	18	IN_5V_9_ADT-
6C	SPL-6	P5A-9	BU	18	IN_5V_9_ADT-
7A	J2A-3	SPL-8	OR	18	IN_5V_10_ADT-
7B	SPL-8	RES-4	OR	18	IN_5V_10_ADT-

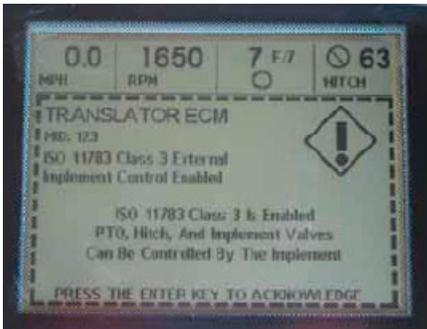
1. Turn off the Autopilot system power switch.
2. Start the tractor.
3. Acknowledge the ISO Class 2 enabled message on the armrest console:

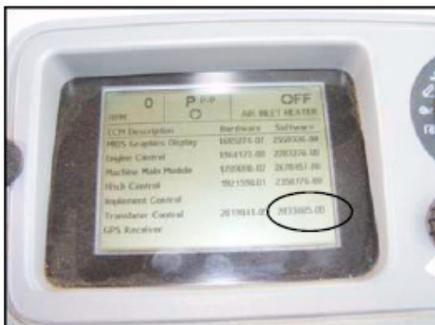
- ▶ **Incorrect version of CAN translator installed:** Verify that the vehicle has the correct version of CAN translator installed. On the tractor armrest MIDS display:
 - a. Turn the upper knob to the hash marks at the 1 o'clock position.
 - b. Press the Enter key and the right arrow key at the same time. The translator software must be version 283-3405-00 or later:

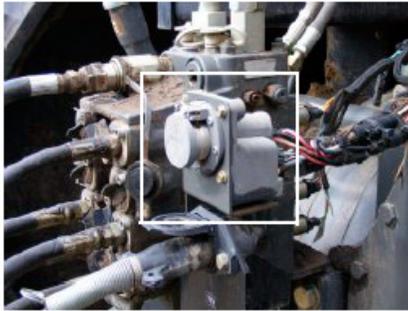
ISO Connector location

- Check that the ISO connector is installed on the rear of the tractor. On the back of the ISO connector are 2 smaller connectors. One connector is a 4-pin DT-Deutsch connector with yellow, green, red, and black wires.

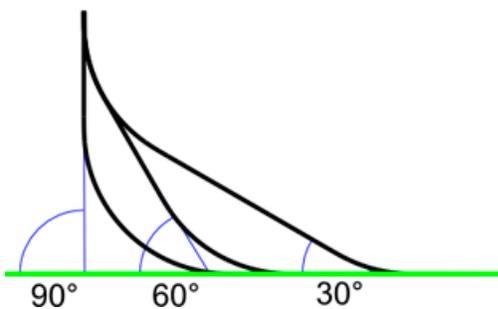
Maximum approach angle to the swath: Set the desired approach angle that the Autopilot system will drive to the line if adequate space is available. If space is not available, the angle may not be achievable. The following figure shows possible paths to the line based on different approach angles:

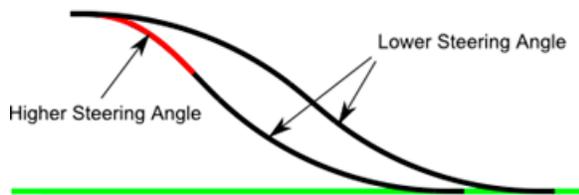
A higher value will turn harder and sharper towards the line. A lower value will have an initial turn that will be smoother and more gradual. The figure below shows different paths based on different initial turn aggressiveness values with the same final turn.

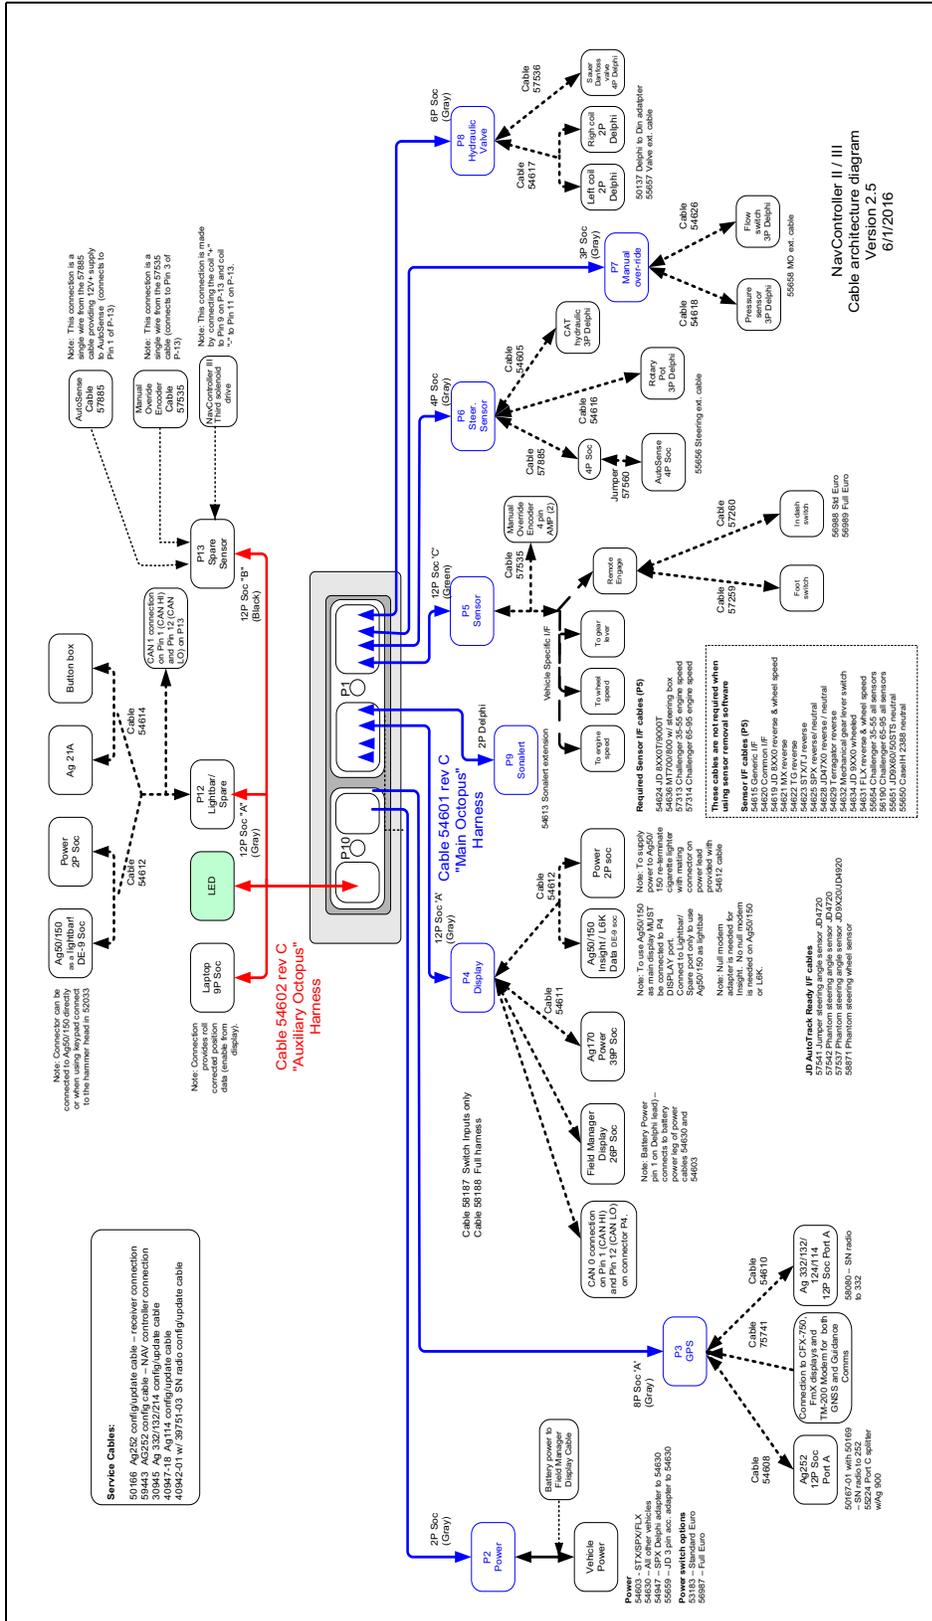
Autopilot system cable architecture

This chapter shows the Autopilot system harness schematics.

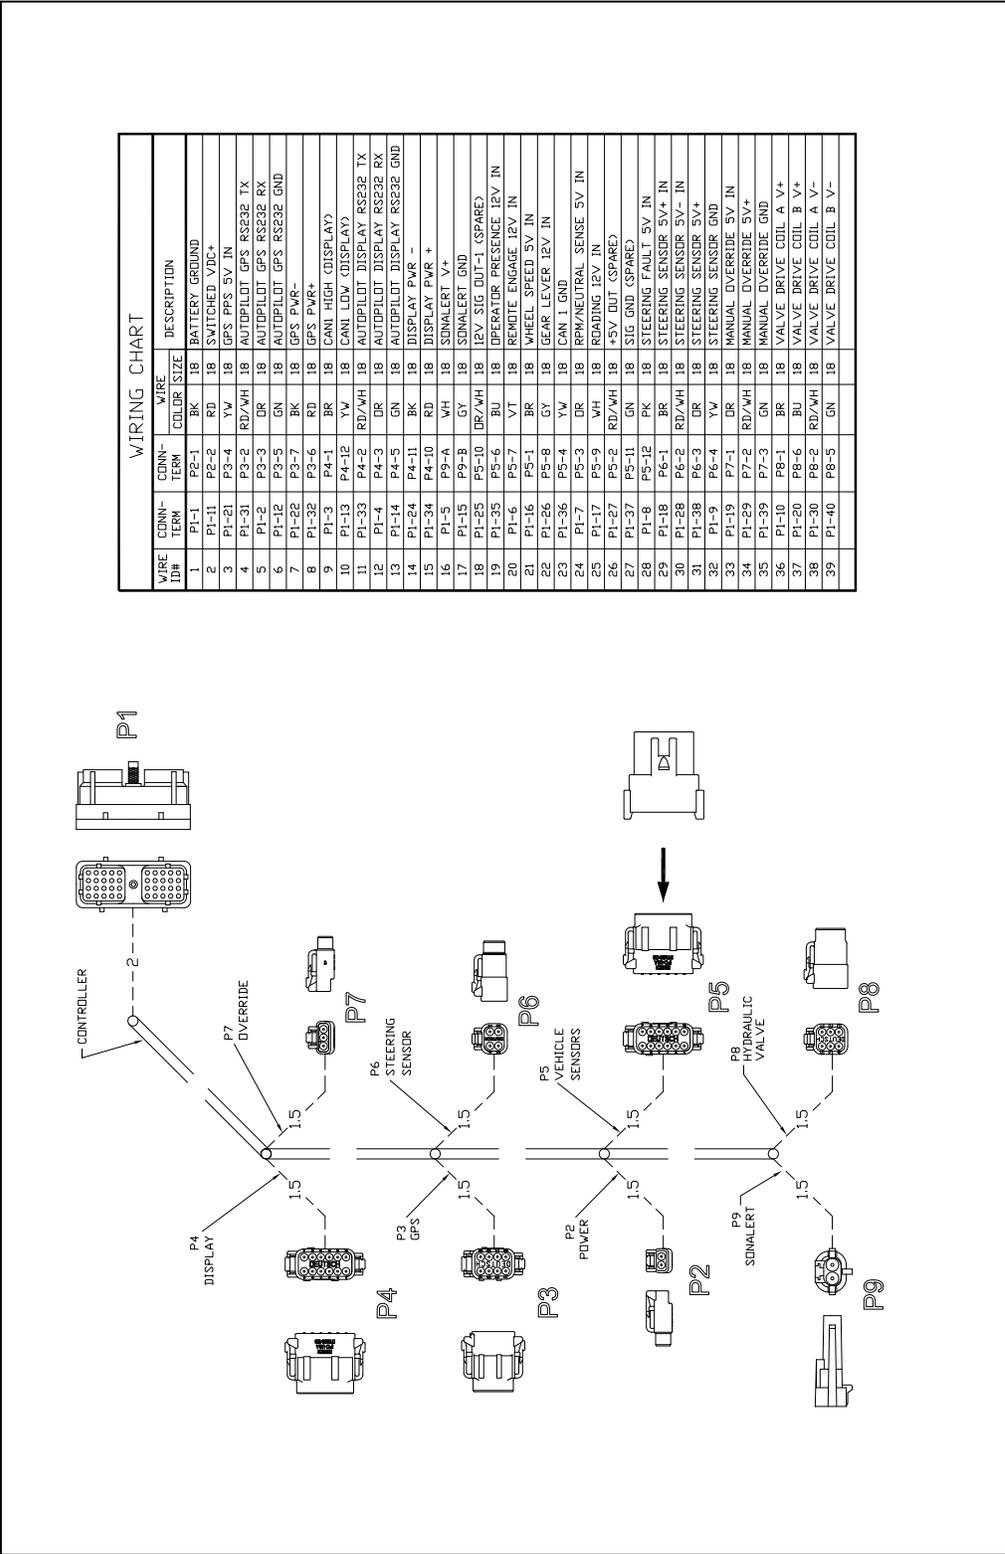
Main harness: P/N 54601

WIRING CHART				
WIRE ID#	CONN-TERM	WIRE COLOR	SIZE	DESCRIPTION
1	P1-1	BK	18	BATTERY VDC+
2	P1-11	RD	18	SWITCHED VDC+
3	P1-21	YW	18	GPS PPS 5V IN
4	P1-31	RD/WH	18	AUTOPILOT GPS RS232 TX
5	P1-2	DR	18	AUTOPILOT GPS RS232 RX
6	P1-12	P3-5	GN	AUTOPILOT GPS RS232 GND
7	P1-22	BK	18	GPS PWR-
8	P1-22	P3-6	RD	GPS PWR+
9	P1-3	P4-1	BR	CAN1 HIGH (DISPLAY)
10	P1-13	P4-12	YW	CAN1 LOW (DISPLAY)
11	P1-33	RD/WH	18	AUTOPILOT_DISPLAY RS232 TX
12	P1-4	DR	18	AUTOPILOT_DISPLAY RS232 RX
13	P1-14	P4-5	GN	AUTOPILOT_DISPLAY RS232 GND
14	P1-24	P4-11	BK	DISPLAY PWR -
15	P1-34	P4-10	RD	DISPLAY PWR +
16	P1-5	P9-A	VH	SIGNALERT V+
17	P1-15	P9-B	GY	SIGNALERT GND
18	P1-25	P5-10	DR/WH	12V SIG OUT-1 (SPARE)
19	P1-35	P5-6	BU	OPERATOR PRESENCE 12V IN
20	P1-6	P5-7	VT	REMOTE ENGAGE 12V IN
21	P1-16	P5-1	BR	WHEEL SPEED 5V IN
22	P1-26	P5-8	GY	GEAR LEVER 12V IN
23	P1-36	P5-4	YW	CAN 1 GND
24	P1-7	P5-3	DR	RPM/NEUTRAL SENSE 5V IN
25	P1-17	P5-9	VH	READING 12V IN

26	P1-27	P5-2	RD/WH	+5V DUT (SPARE)
27	P1-37	P5-11	GN	SIG GND (SPARE)
28	P1-8	P5-12	PK	STEERING FAULT 5V IN
29	P1-18	P6-1	BR	STEERING SENSOR 5V+ IN
30	P1-28	P6-2	RD/WH	STEERING SENSOR 5V- IN
31	P1-38	P6-3	DR	STEERING SENSOR 5V+
32	P1-9	P6-4	YW	STEERING SENSOR GND
33	P1-19	P7-1	DR	MANUAL OVERRIDE 5V IN
34	P1-29	P7-2	RD/WH	MANUAL OVERRIDE 5V+
35	P1-39	P7-3	GN	MANUAL OVERRIDE GND
36	P1-10	P8-1	BR	VALVE DRIVE COIL A V+
37	P1-20	P8-6	BU	VALVE DRIVE COIL B V+
38	P1-30	P8-2	RD/WH	VALVE DRIVE COIL A V-
39	P1-40	P8-5	GN	VALVE DRIVE COIL B V-

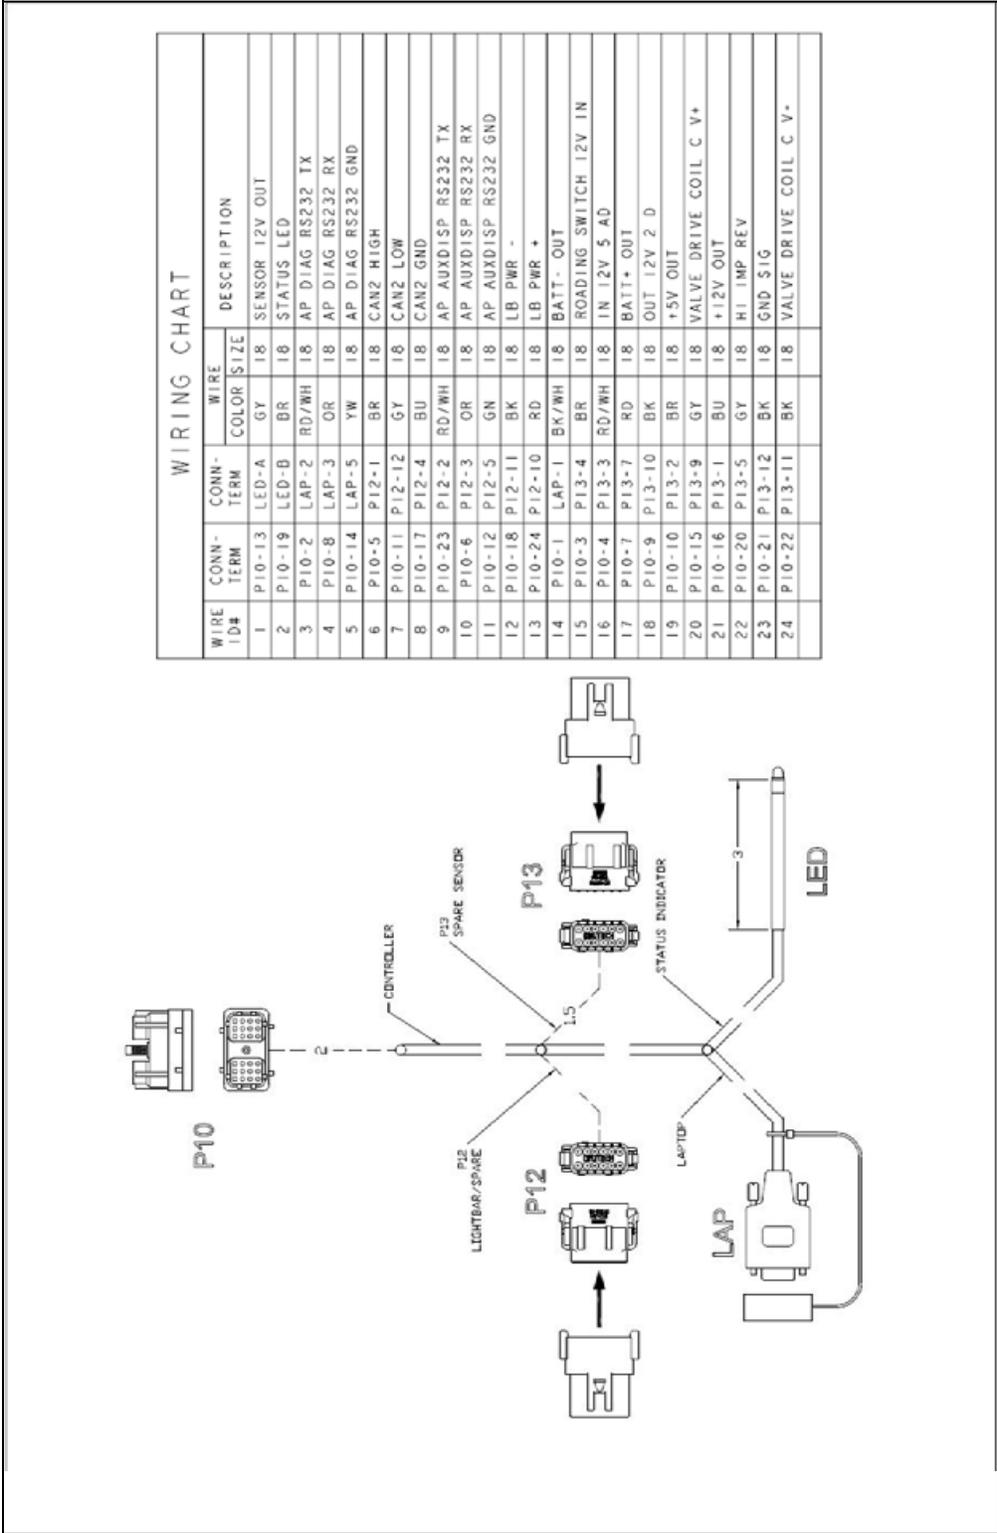
Auxiliary harness: P/N 54602

WIRE ID#	CONN-TERM	CONN-TERM	WIRE		DESCRIPTION
			COLOR	SIZE	
1	P10-13	LED-A	GY	18	SENSOR 12V OUT
2	P10-19	LED-B	BR	18	STATUS LED
3	P10-2	LAP-2	RD/WH	18	AP DIAG RS232 TX
4	P10-8	LAP-3	OR	18	AP DIAG RS232 RX
5	P10-14	LAP-5	YW	18	AP DIAG RS232 GND
6	P10-5	P12-1	BR	18	CAN2 HIGH
7	P10-11	P12-12	GY	18	CAN2 LOW
8	P10-17	P12-4	BU	18	CAN2 GND
9	P10-23	P12-2	RD/WH	18	AP AUXDISP RS232 TX
10	P10-6	P12-3	OR	18	AP AUXDISP RS232 RX
11	P10-12	P12-5	GN	18	AP AUXDISP RS232 GND
12	P10-18	P12-11	BK	18	LB PWR -
13	P10-24	P12-10	RD	18	LB PWR +
14	P10-1	LAP-1	BK/WH	18	BATT- OUT
15	P10-3	P13-4	BR	18	ROADING SWITCH 12V IN
16	P10-4	P13-3	RD/WH	18	IN 12V 5 A0
17	P10-7	P13-7	RD	18	BATT+ OUT
18	P10-9	P13-10	BK	18	OUT 12V 2 D
19	P10-10	P13-2	BR	18	+5V OUT
20	P10-15	P13-9	GY	18	VALVE DRIVE COIL C V+
21	P10-16	P13-1	BU	18	+12V OUT
22	P10-20	P13-5	GY	18	HI IMP REV
23	P10-21	P13-12	BK	18	GND SIG
24	P10-22	P13-11	BK	18	VALVE DRIVE COIL C V-

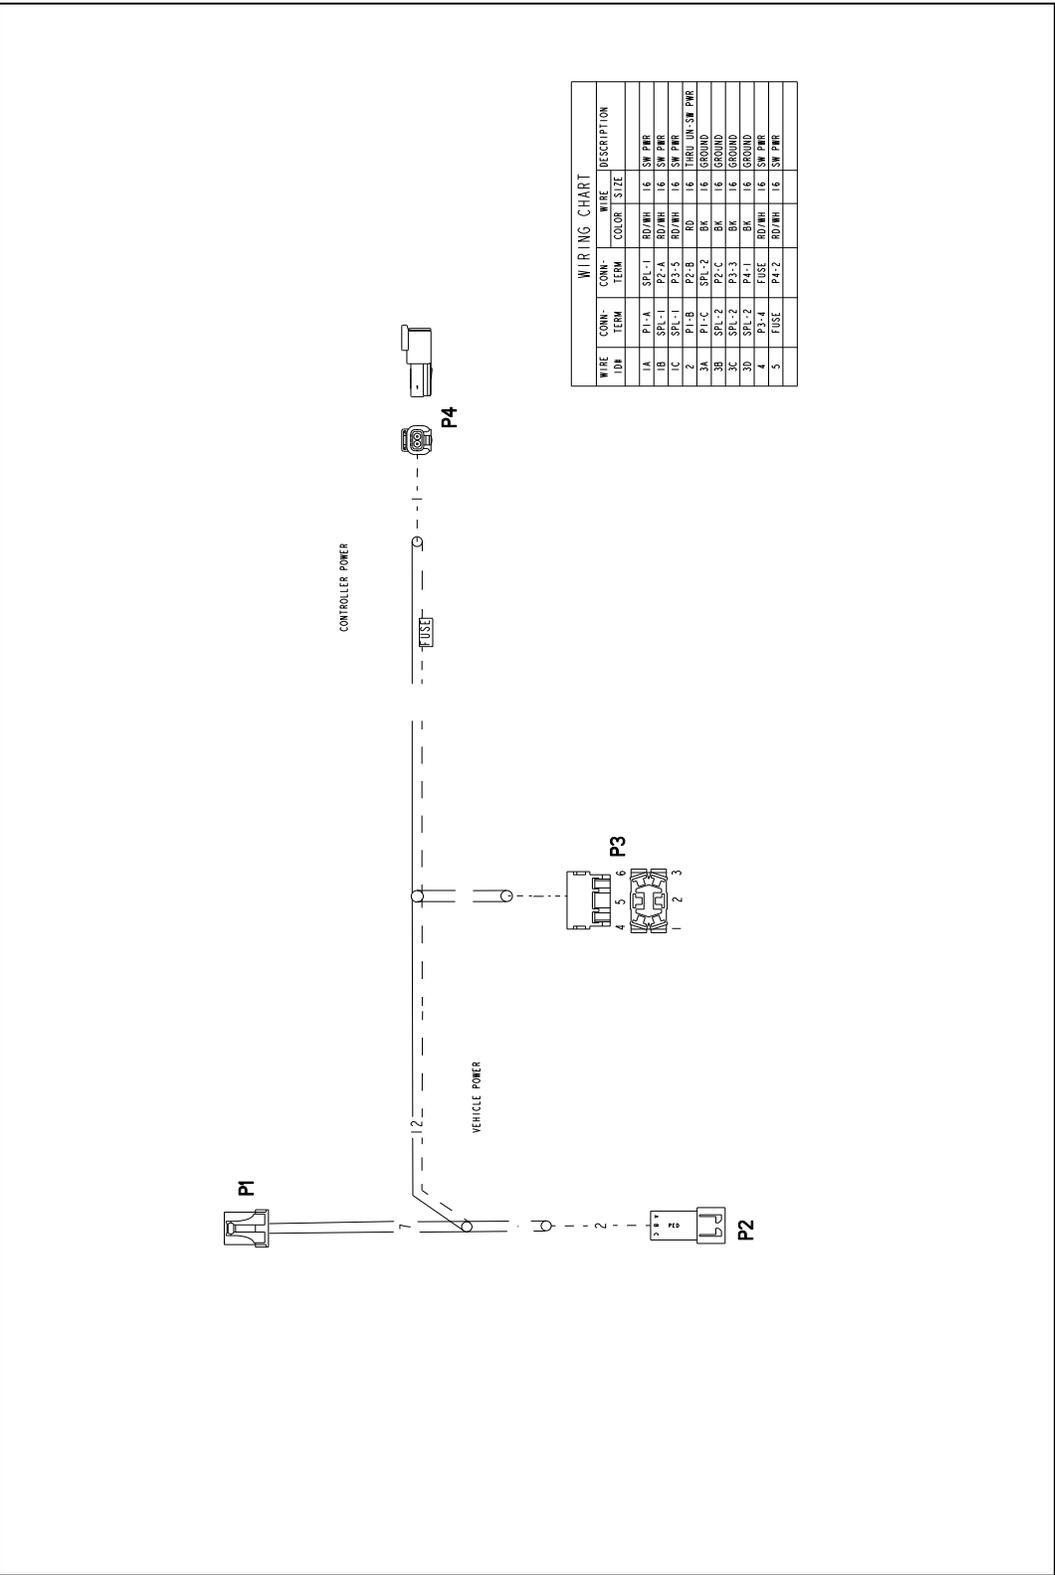
SPX/STX/FLX power harness: P/N 54603

WIRING CHART					
WIRE ID#	CONV. TERM.	CONV. TERM.	WIRE COLOR	WIRE SIZE	DESCRIPTION
1A	P1-A	SPL-1	RD/WH	16	SW PWR
1B	SPL-1	P2-A	RD/WH	16	SW PWR
1C	SPL-1	P3-5	RD/WH	16	SW PWR
2	P1-B	P2-B	RD	16	THRU UN-SW PWR
3A	P1-C	SPL-2	BK	16	GROUND
3B	SPL-2	P2-C	BK	16	GROUND
3C	SPL-2	P3-3	BK	16	GROUND
4	P1-D	P3-4	RD/WH	16	SW PWR
5	FUSE	PA-2	RD/WH	16	SW PWR

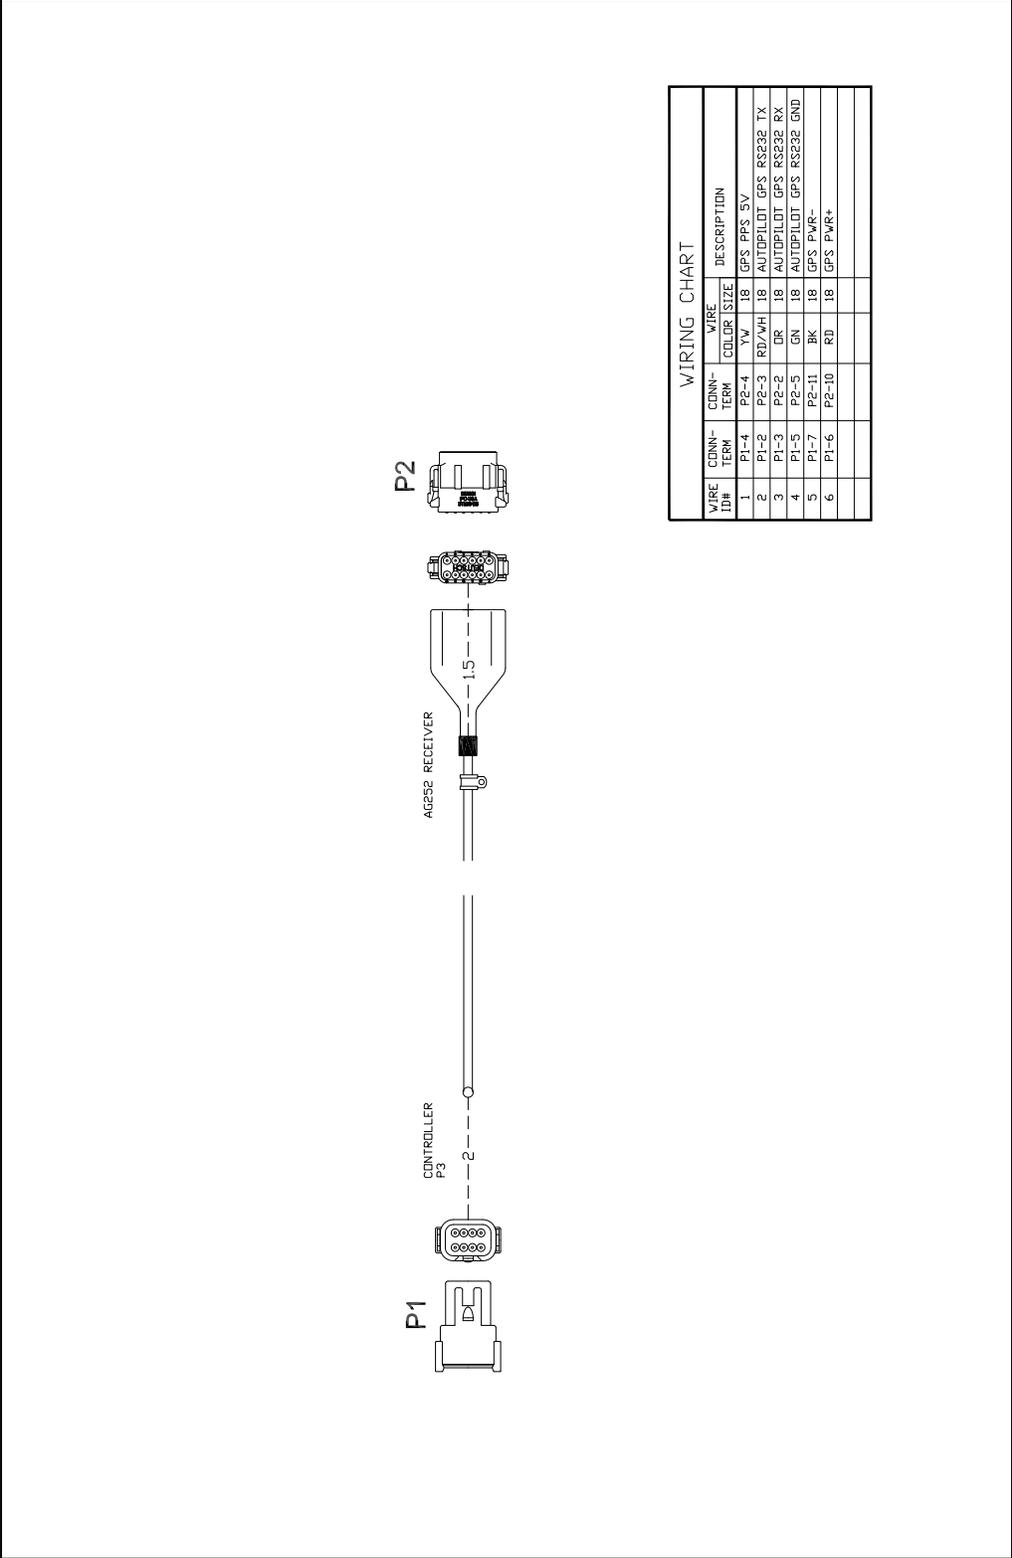
AgGPS 252 receiver harness: P/N 54608

WIRE ID#	CONN-TERM	WIRE COLOR	WIRE SIZE	DESCRIPTION
1	P1-4	YW	18	GPS PPS SV
2	P2-4	YW	18	AUTOPILOT GPS RSE32 TX
3	P1-2	RD/WH	18	AUTOPILOT GPS RSE32 RX
4	P2-2	DR	18	AUTOPILOT GPS RSE32 RX
5	P1-5	GN	18	AUTOPILOT GPS RSE32 GND
6	P2-5	GN	18	AUTOPILOT GPS RSE32 GND
	P1-7	BK	18	GPS PWR-
	P2-10	RD	18	GPS PWR+

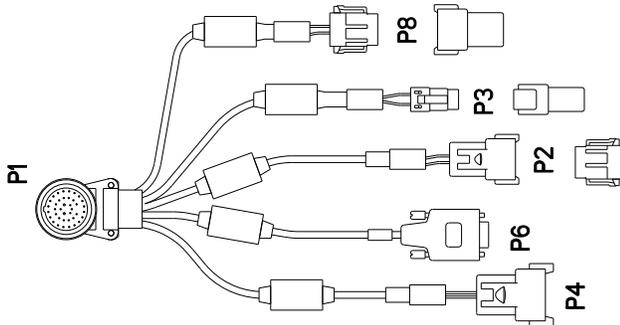
AgGPS 170 Field Computer harness: P/N 54611

P1	MAIN CONNECTOR DESCRIPTION	WIRING AND PIN OUT CHART				TERMINATES AT				
		JUMPERS	WIRE USED	WIRE BUNDLE COND.	COLOR	P2	P3	P4	P6	P8
M	CANLO		BB	BB	YELLOW		1			
L	CANFO		BB	BB	BROWN		4			
e	CANCO		BB	BB	BROWN		4			
					GREEN		2			
A	Brp0 Grd		AA	AA	ORANGE		5			
B	SWMO		AA	AA	WHITE		1			
D	Boil +	JUMPER	CC	CC	RED			IO		6
E	Boil +	JUMPER [20]	CC	CC	RED					
F	Boil -	JUMPER	CC	CC	BLK			II		7
G	Boil -	JUMPER [20]	CC	CC	BLK					
P	TXD2		GG	GG	BROWN					3
N	RXD2		GG	GG	ORANGE					2
R	GN2		GG	GG	YELLOW					5
S	GN2		GG	GG	YELLOW					5
T	RXD1		CC	CC	ORANGE					2
U	TXD1		CC	CC	BROWN					3
X	Brp0		AA	AA	GREEN			4		
Y	SWMI		AA	AA	BLUE			6		
f	RTSO		EE	EE	RED					7
g	CTSO		EE	EE	BLACK					8
h	RXD0		EE	EE	ORANGE					2
i	TXD0		EE	EE	BROWN					3
k	SWME		AA	AA	RED/BLK			7		
n	AWAKE GND		AA	AA	YELLOW			8		
d	AWAKE		AA	AA	ORANGE			3		
q	GND0		EE	EE	YELLOW					5
