Autopilot

AUTOMATED STEERING SYSTEM

Version 4.00
Revision A
September 2016

This is the October 2016 release (Revision A) of the *Autopilot Automated Steering System Troubleshooting Guide*. It applies to version 4.00 of the NextSwath Vehicle Integration End-of-Row Turn Technology.

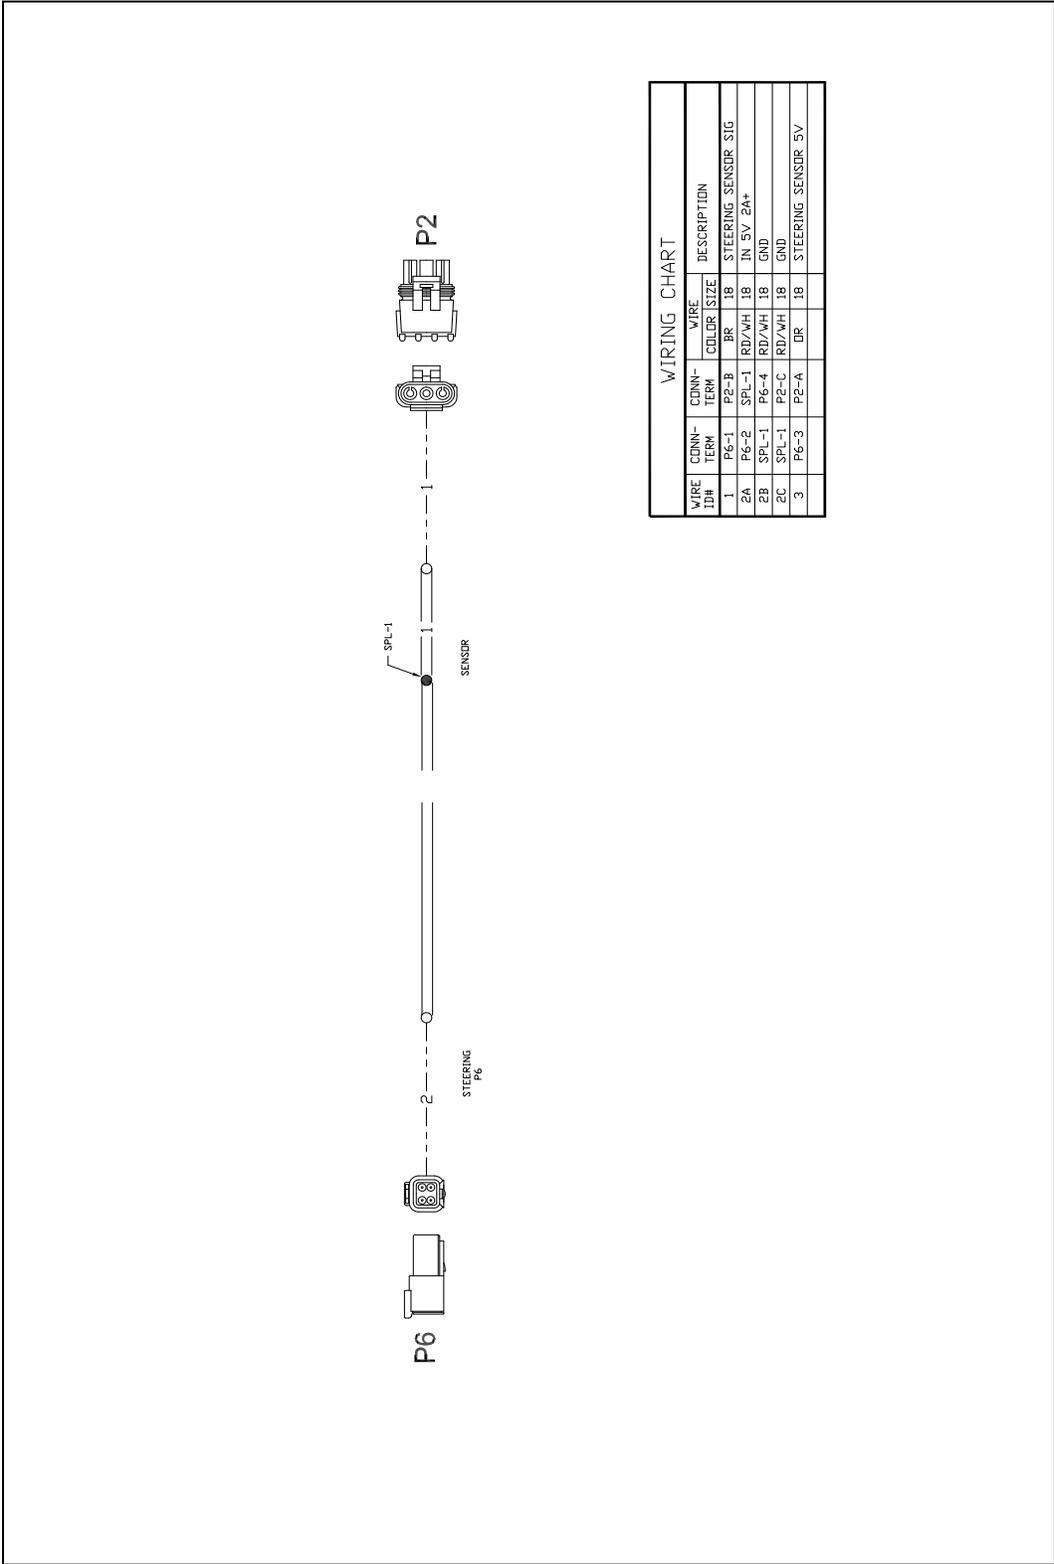
Steering angle sensor harness: P/N 54616

WIRE ID#	CONN- TERM	CONN- TERM	WIRE COLOR	WIRE SIZE	DESCRIPTION
1	P6-1	P2-B	BR	18	STEERING SENSOR SIG
2A	P6-2	SPL-1	RD/WH	18	IN 5V 2A+
2B	SPL-1	P6-4	RD/WH	18	GND
2C	SPL-1	P2-C	RD/WH	18	GND
3	P6-3	P2-A	DR	18	STEERING SENSOR 5V

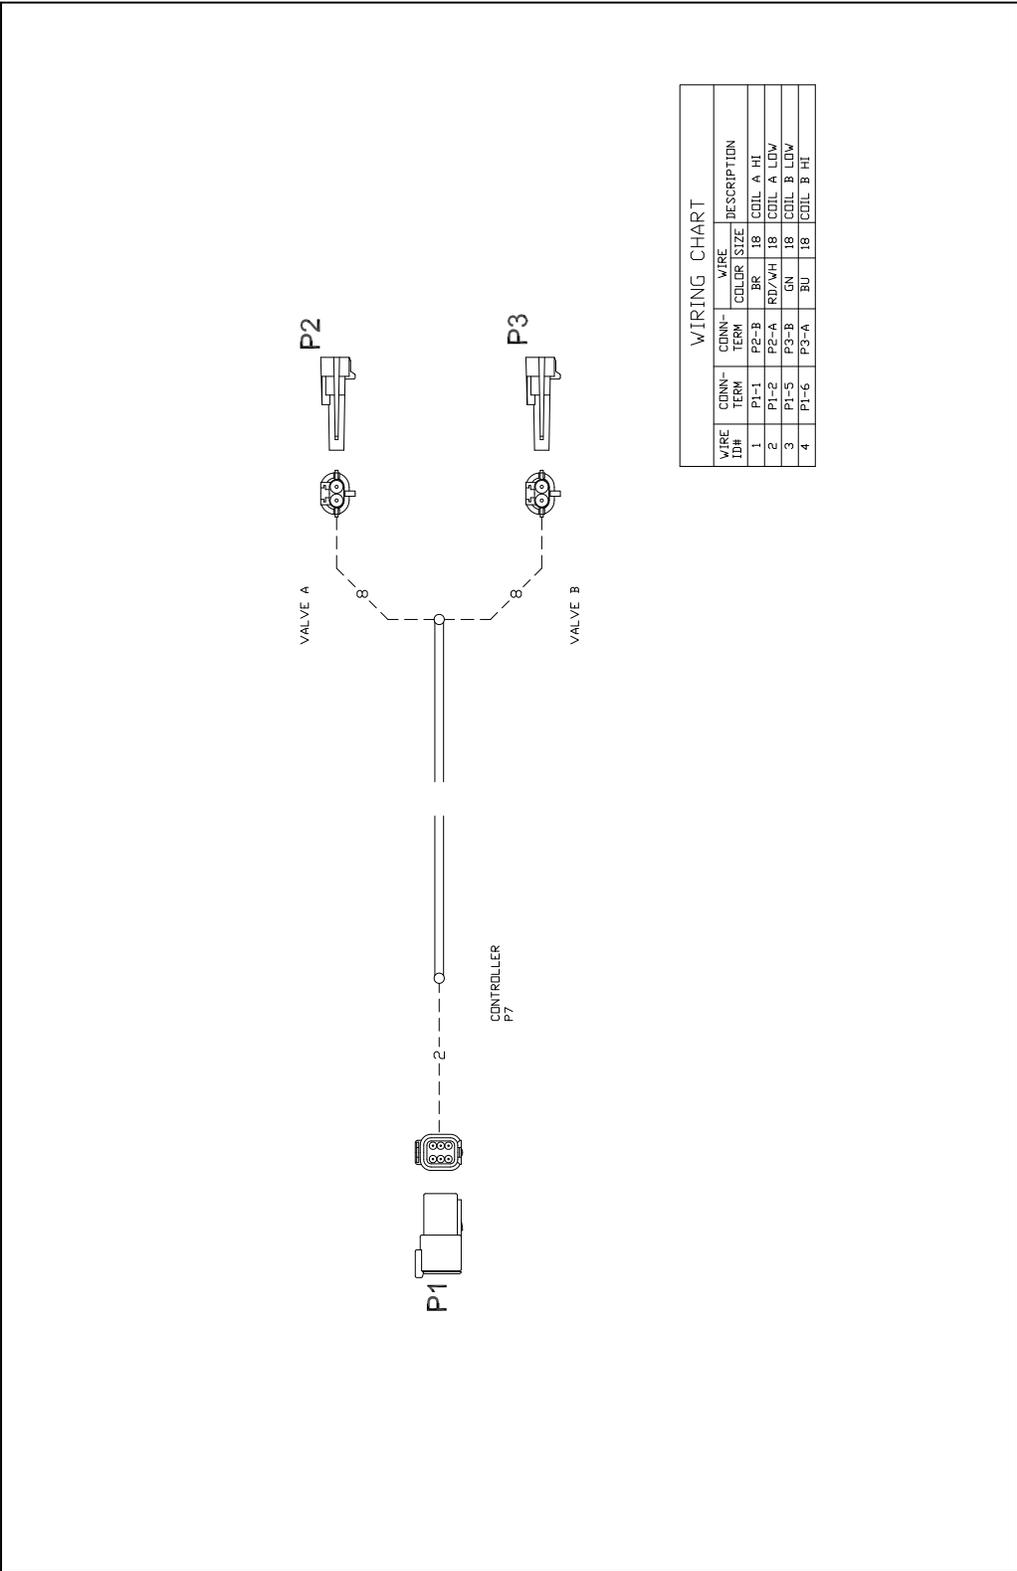
Electro hydraulic valve harness: P/N 54617

WIRE ID#	CONN-TERM	CONN-TERM	WIRE		DESCRIPTION
			COLOR	SIZE	
1	P1-1	P2-B	BR	18	COIL A HI
2	P1-2	P2-A	RD/WH	18	COIL A LOW
3	P1-5	P3-B	GN	18	COIL B LOW
4	P1-6	P3-A	BU	18	COIL B HI

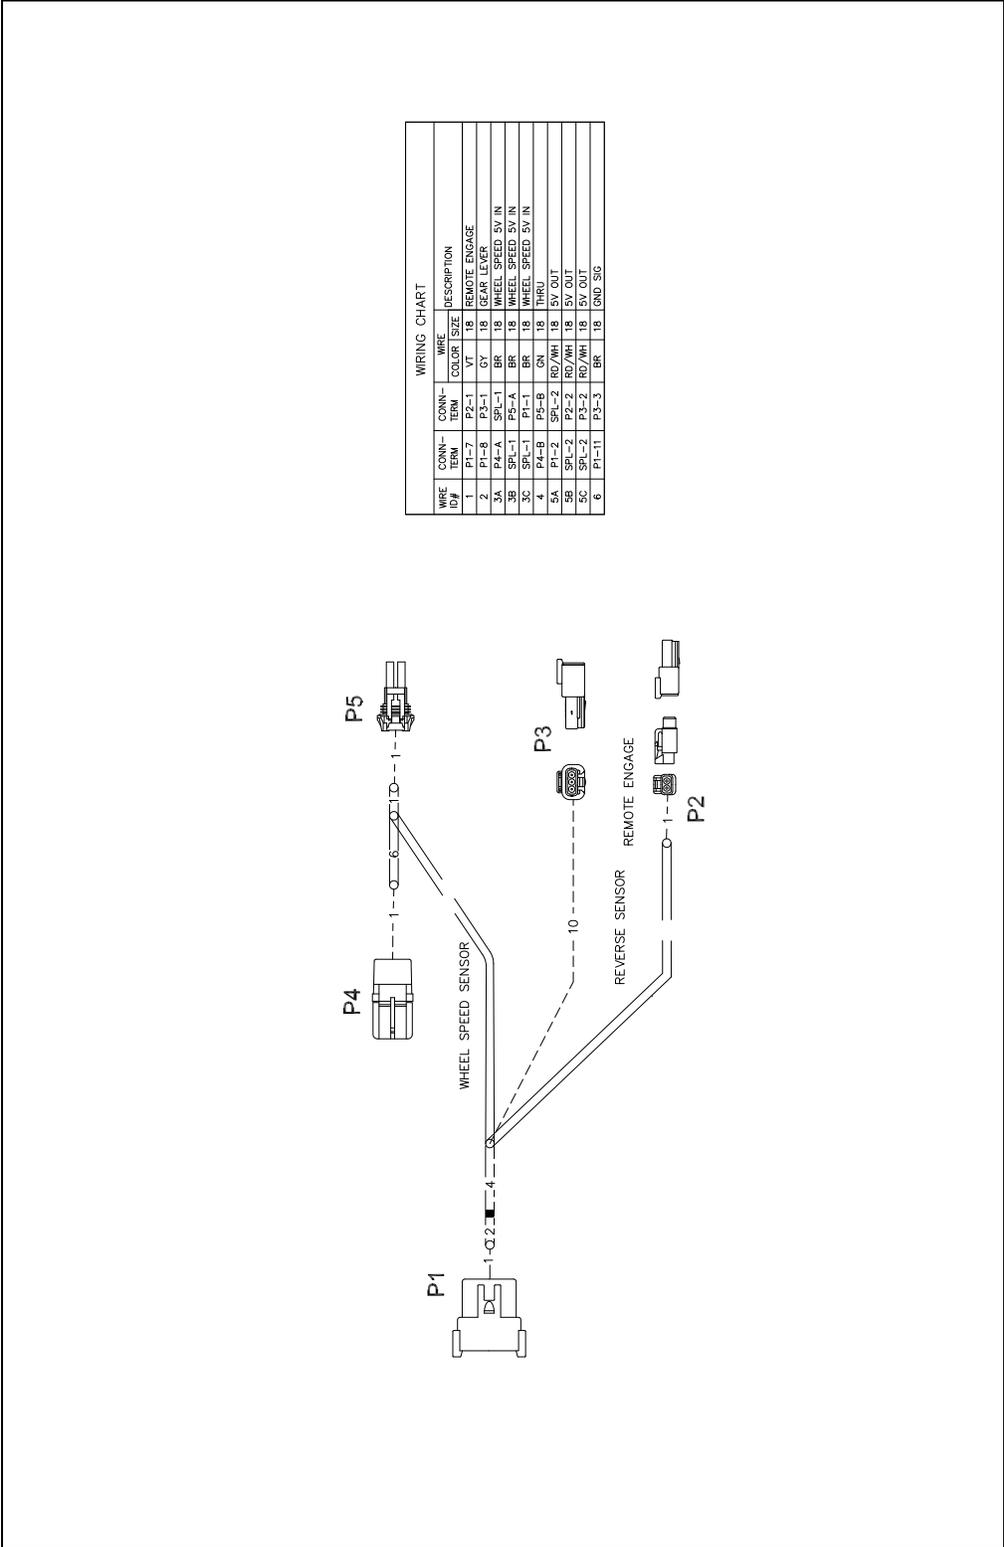
Common interface harness: P/N 54620

WIRE ID#	CONN-TERM	CONN-TERM	WIRE COLOR	WIRE SIZE	DESCRIPTION
1	P1-7	P2-1	VT	18	REMOTE ENGAGE
2	P1-8	P3-1	GY	18	GEAR LEVER
3A	P4-A	SPL-1	BR	18	WHEEL SPEED 5V IN
3B	SPL-1	P5-A	BR	18	WHEEL SPEED 5V IN
4	P1-1	P4-B	GN	18	THRU
5A	P1-2	SPL-2	RD/WH	18	5V OUT
5B	SPL-2	P2-2	RD/WH	18	5V OUT
5C	SPL-2	P3-2	RD/WH	18	5V OUT
6	P1-11	P3-3	BR	18	OND SIG

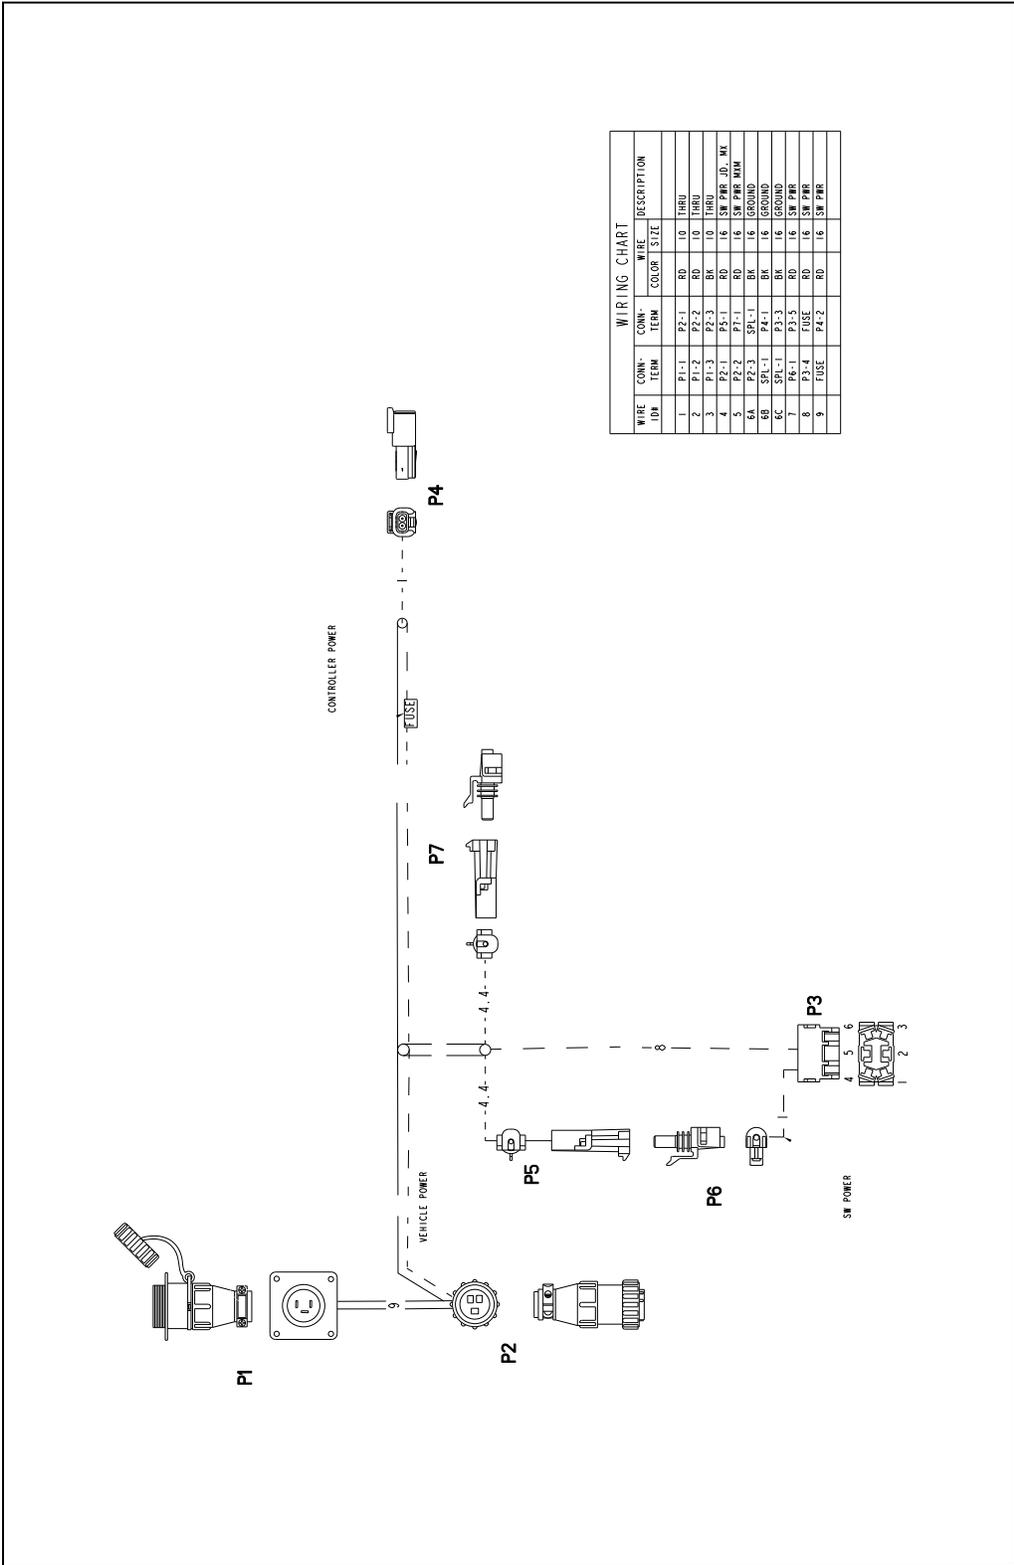
John Deere/Cat MT power interface harness: P/N 54630

WIRE ID#	CONN. TERM.	CONN. TERM.	WIRE		DESCRIPTION
			COLOR	SIZE	
1	P1-1	P2-1	RD	10	THRU
2	P1-2	P2-2	RD	10	THRU
3	P1-3	P2-3	BK	10	THRU
4	P2-1	P5-1	RD	16	SW PWR JD_MK
5	P2-2	P7-1	RD	16	SW PWR MIN
6A	P2-3	SPT-1	BK	16	GROUND
6B	P2-3	SPT-1	BK	16	GROUND
7	P6-1	P3-3	RD	16	SW PWR
8	P3-4	FUSE	RD	16	SW PWR
9	FUSE	P4-2	RD	16	SW PWR

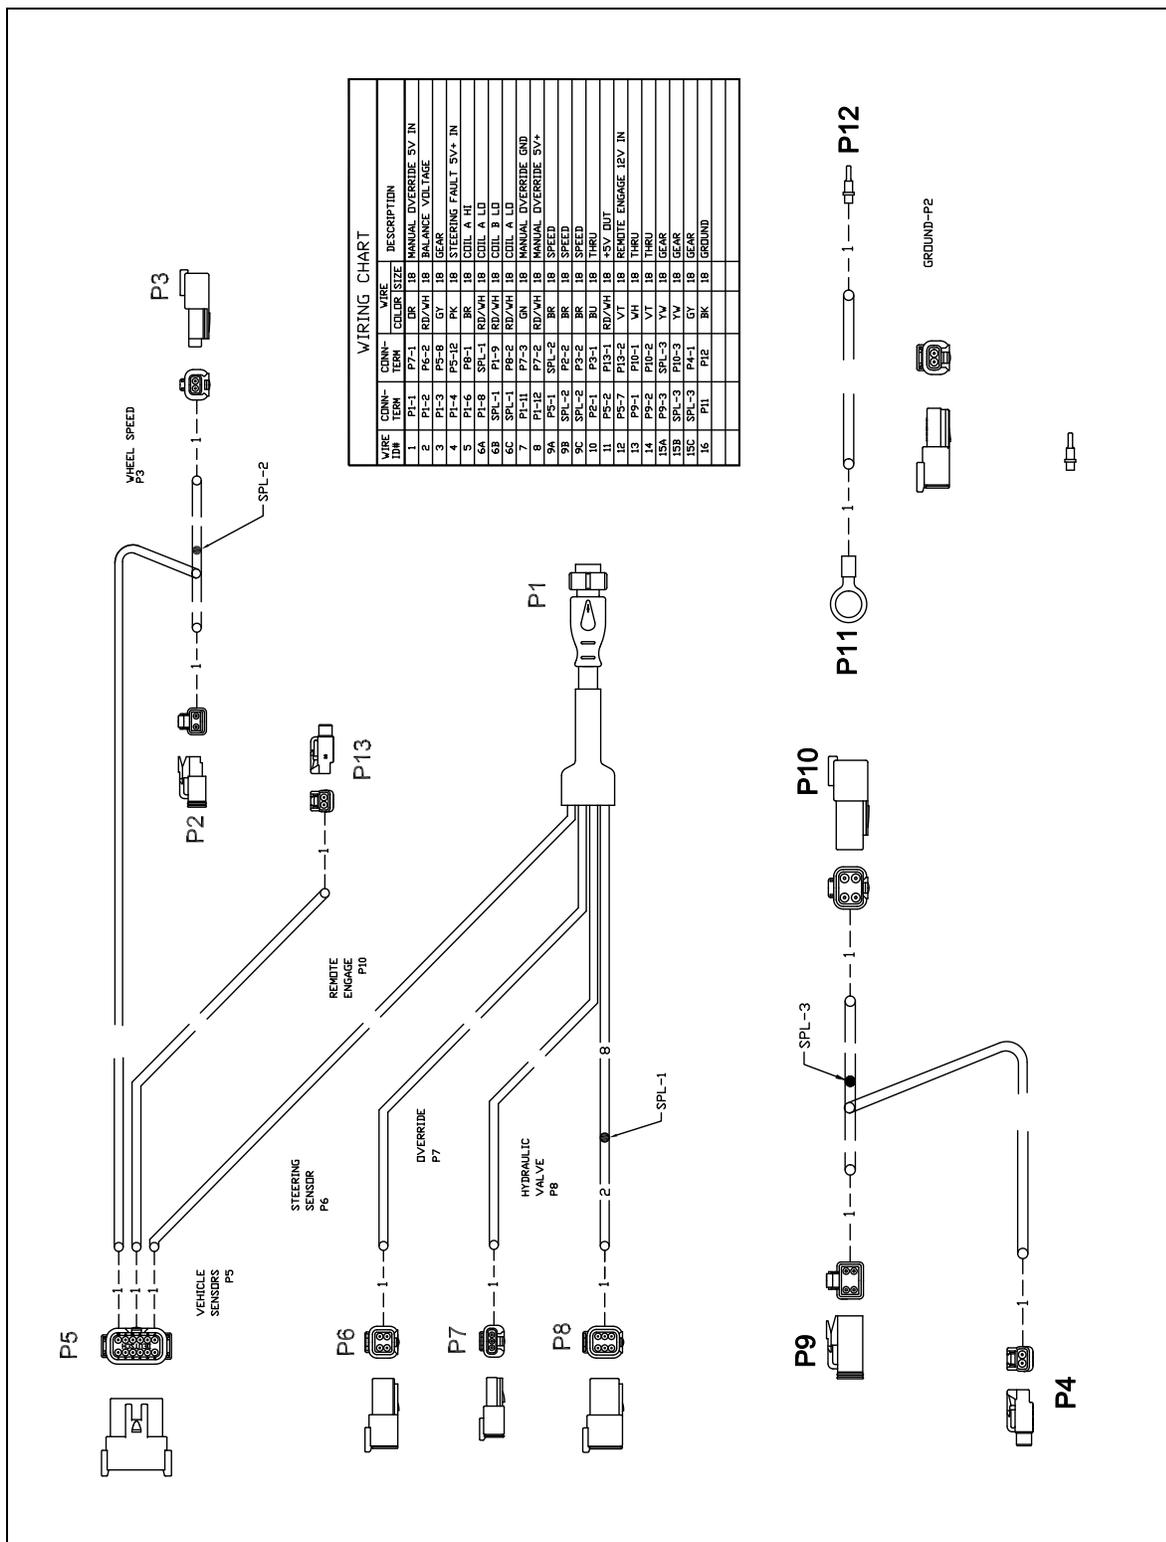
Challenger MT interface harness: P/N 54636

WIRE ID#	CONN. TERM	CONN. TERM	WIRE COLOR	WIRE SIZE	DESCRIPTION
1	P1-1	P7-1	DR	18	MANUAL OVERRIDE SV IN
2	P1-2	P6-2	RD/VH	18	BALANCE VOLTAGE
3	P1-3	P5-8	GY	18	IGEAR
4	P1-4	P5-2	BK	18	STEERING FAULT SV+ IN
5	P1-5	P5-1	RD/VH	18	COIL A LU
6	P1-6	P5-1	RD/VH	18	COIL B LU
6C	SPL-1	P6-2	RD/VH	18	COIL A LU
7	P1-11	P7-3	GN	18	MANUAL OVERRIDE GND
8	P1-12	P7-2	RD/VH	18	MANUAL OVERRIDE SV+
9A	P5-1	SPL-2	BR	18	SPEED
9B	SPL-2	P5-2	BR	18	SPEED
10	P5-2	P5-1	BK	18	THRU
11	P5-1	P5-1	BK	18	THRU
12	P5-2	P13-1	RD/VH	18	+SV OUT
13	P5-7	P13-2	VT	18	REMOTE ENGAGE 12V IN
14	P9-1	P10-1	VH	18	THRU
15A	P9-2	P10-2	VT	18	THRU
15B	SPL-3	P10-3	YV	18	IGEAR
15C	SPL-3	P10-3	YV	18	IGEAR
15E	SPL-3	P10-3	YV	18	IGEAR
16	P11	P12	BK	18	GROUND

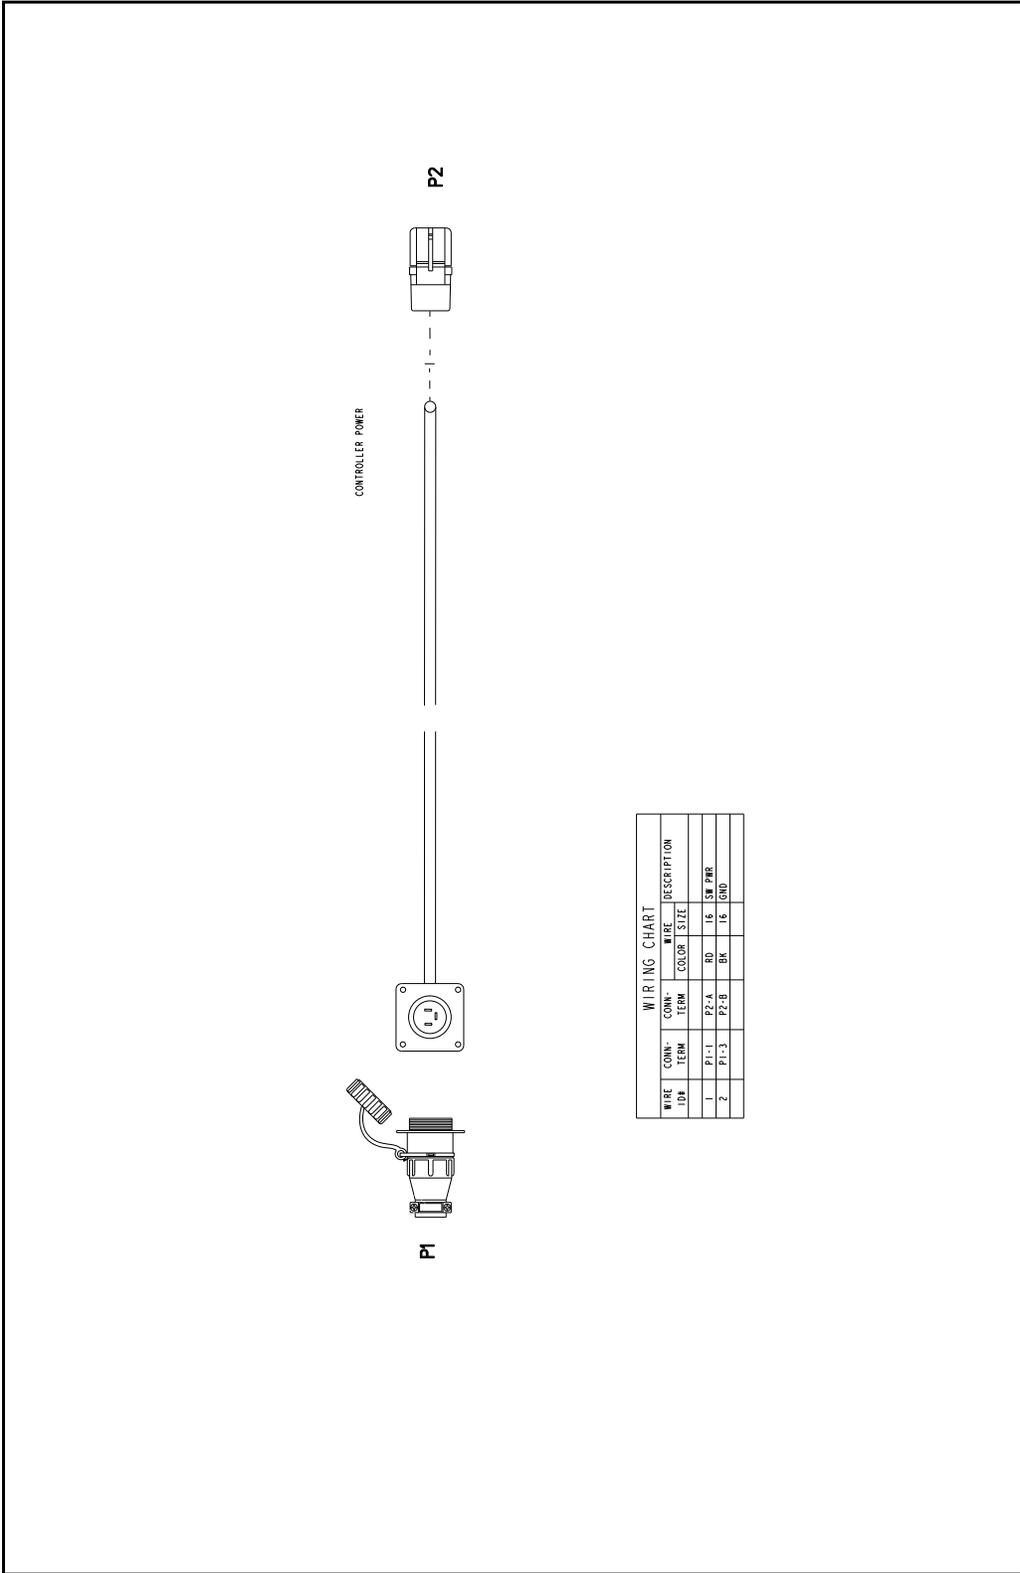
SPX Power Adapter: P/N 54947

WIRING CHART				
WIRE ID	CONV. TERM	WIRE COLOR	WIRE SIZE	DESCRIPTION
1	P1-1	RD	16	SW PWR
2	P1-3	BK	16	GRD

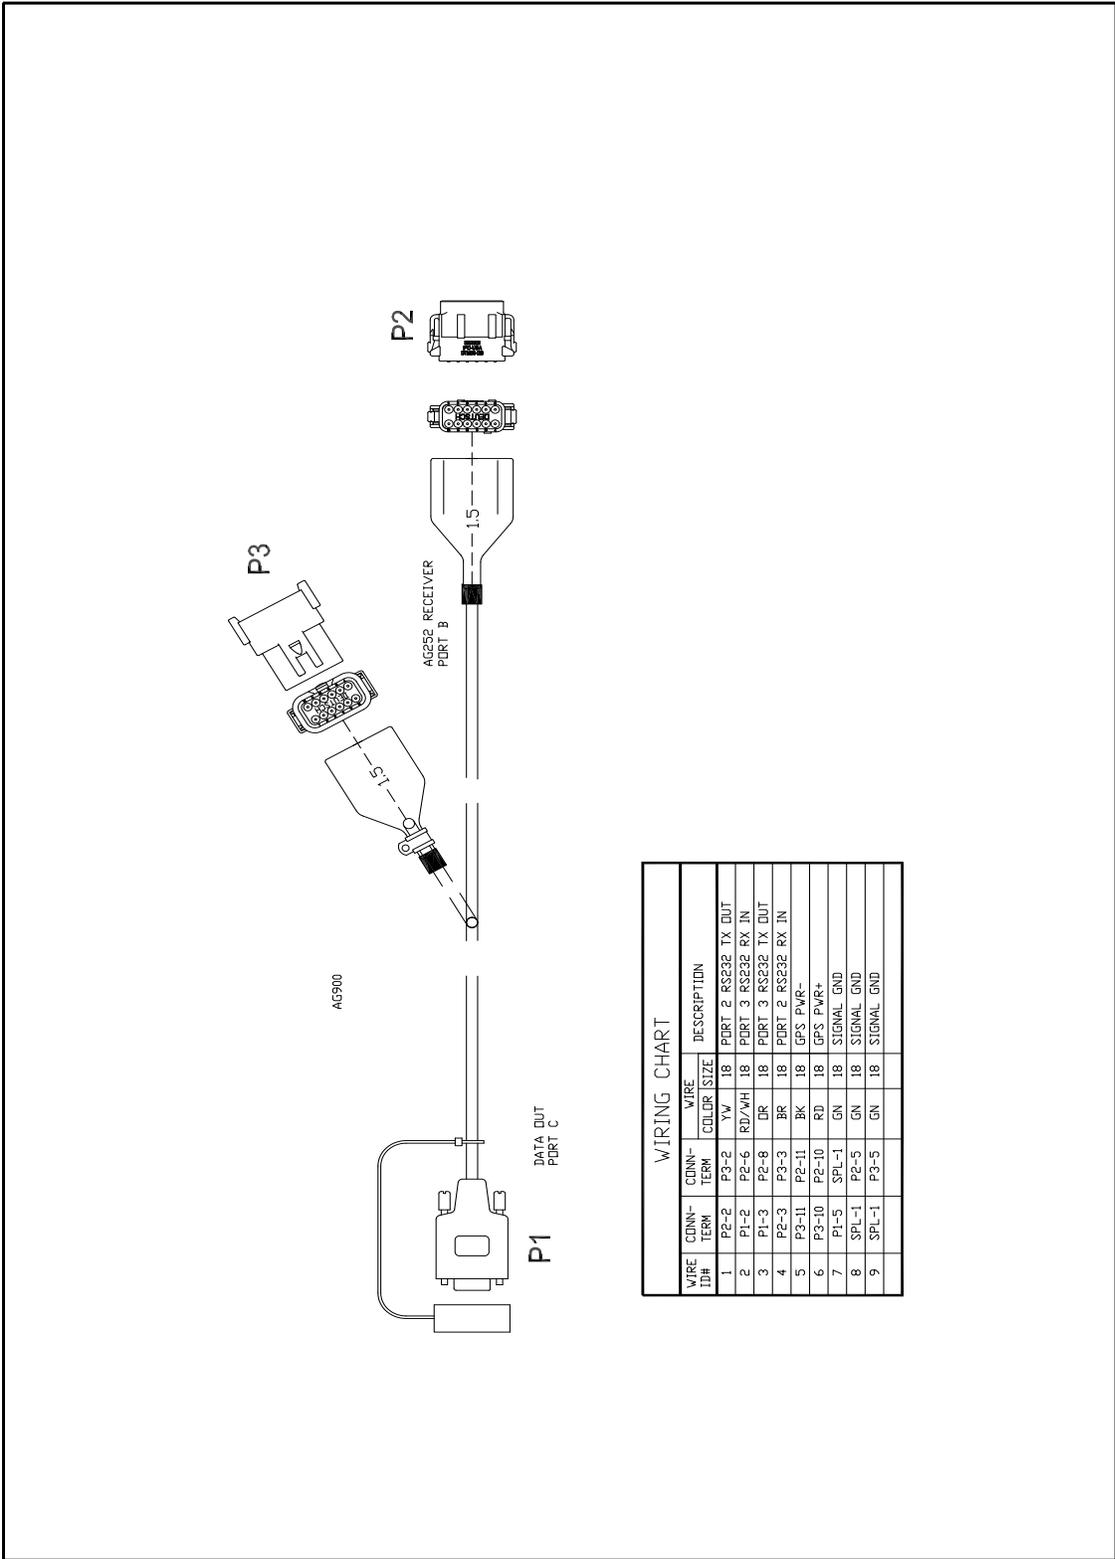
AgGPS 252 data harness: P/N 55224

WIRE ID#	CONN-TERM	CONN-TERM	WIRE		DESCRIPTION
			COLOR	SIZE	
1	P2-2	P3-2	YW	18	PORT 2 RS232 TX OUT
2	P1-2	P2-6	RD/WH	18	PORT 3 RS232 RX IN
3	P1-3	P2-8	BR	18	PORT 3 RS232 TX OUT
4	P2-3	P3-3	BR	18	PORT 2 RS232 RX IN
5	P3-11	P2-11	BK	18	GPS PWR-
6	P3-10	P2-10	RD	18	GPS PWR+
7	P1-5	SPL-1	GN	18	SIGNAL GND
8	SPL-1	P2-5	GN	18	SIGNAL GND
9	SPL-1	P3-5	GN	18	SIGNAL GND

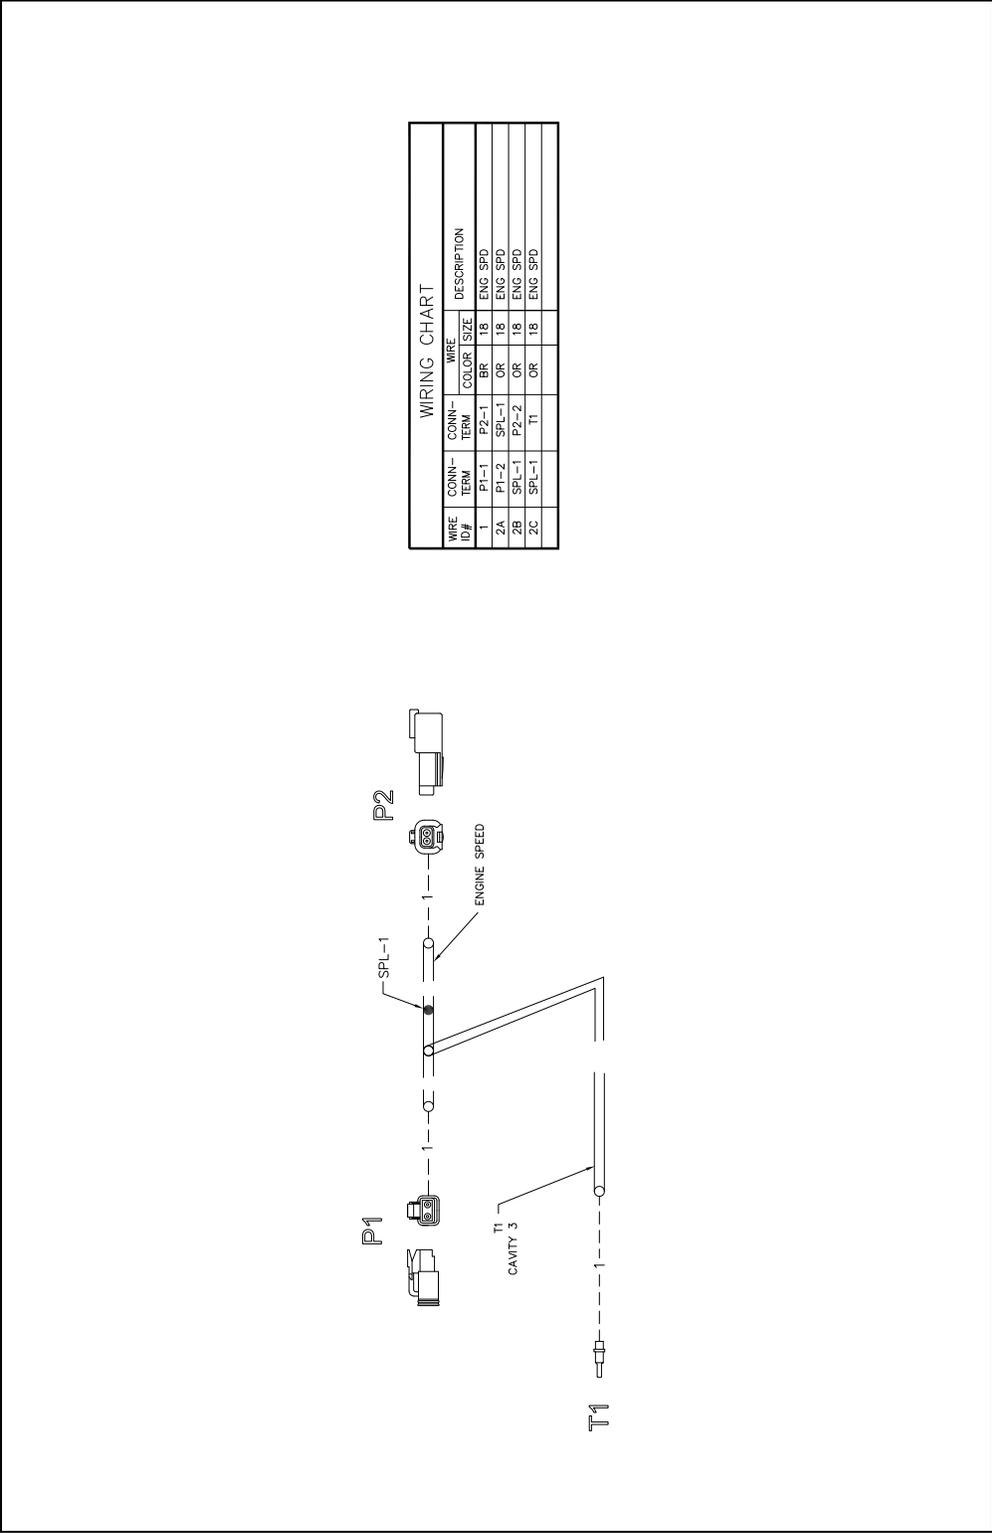
Challenger 35–55 engine interface harness: P/N 57313

WIRING CHART				
WIRE ID#	CONN-TERM	CONN-TERM	WIRE COLOR	DESCRIPTION
1	P1-1	P2-1	BR	ENG SPD
2A	P1-2	SPL-1	OR	ENG SPD
2B	SPL-1	P2-2	OR	ENG SPD
2C	SPL-1	T1	OR	ENG SPD

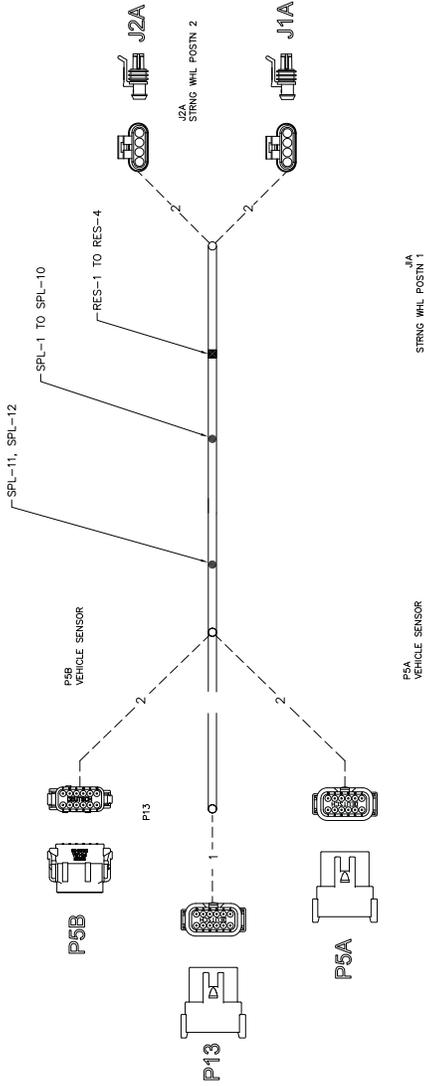
John Deere AutoTrac manual override harness: P/N 57535

WIRING CHART					
WIRE ID	CONN-TO	WIRE COLOR	WIRE SIZE	DESCRIPTION	
1B	SPL-1	WH	18	+5V OUT	
1C	SPL-1	WH	18	+5V OUT	
1D	SPL-3	WH	18	+5V OUT	
1E	SPL-3	WH	18	+5V OUT	
1F	SPL-9	WH	18	+5V OUT	
2A	J1A-2	YW	18	IN_5V_E_A01+	
2B	SPL-2	RES-1	YW	18	IN_5V_E_A01+
2C	SPL-2	P5A-4	YW	18	IN_5V_E_A01+
3A	J1A-3	OR	18	IN_5V_S_A01-	
3B	SPL-4	RES-2	OR	18	IN_5V_S_A01-
3C	SPL-4	P5A-3	OR	18	IN_5V_S_A01-
4A	J1A-4	BK	18	OND_SIG	
4B	SPL-10	SPL-12	BK	18	OND_SIG
4C	SPL-12	P5A-11	BK	18	OND_SIG
5A	J2A-1	SPL-5	GY	18	
5B	SPL-5	RES-3	GY	18	
5C	SPL-5	SPL-7	GY	18	
5D	SPL-7	RES-4	GY	18	
5E	SPL-7	SPL-9	GY	18	
6A	J2A-2	SPL-6	BU	18	IN_5V_S_A01-
6B	SPL-6	RES-3	BU	18	IN_5V_S_A01-
6C	SPL-6	P5A-9	BU	18	IN_5V_S_A01-
7A	J2A-3	OR	18	IN_5V_10_A01-	
7B	SPL-8	RES-5	OR	18	IN_5V_10_A01-
7C	SPL-8	P13-3	OR	18	IN_5V_10_A01-
8	J2A-4	SPL-10	BK	18	OND_SIG
9	P5B-1	P5A-1	BR	18	
10A	P5B-2	SPL-11	RD/WHT	18	+5V OUT
10B	SPL-11	P5A-2	RD/WHT	18	+5V OUT
11	P5B-5	P5A-5	OR	18	
12	P5B-6	P5A-6	BU	18

13	P5B-7	P5A-7	GY	18	
14	P5B-8	P5A-8	GY	18	
15	P5B-10	P5A-10	OR/WHT	18	OND_SIG
16	P5B-11	SPL-12	BK	18	OND_SIG
17	P5B-12	P5A-12	WH	18

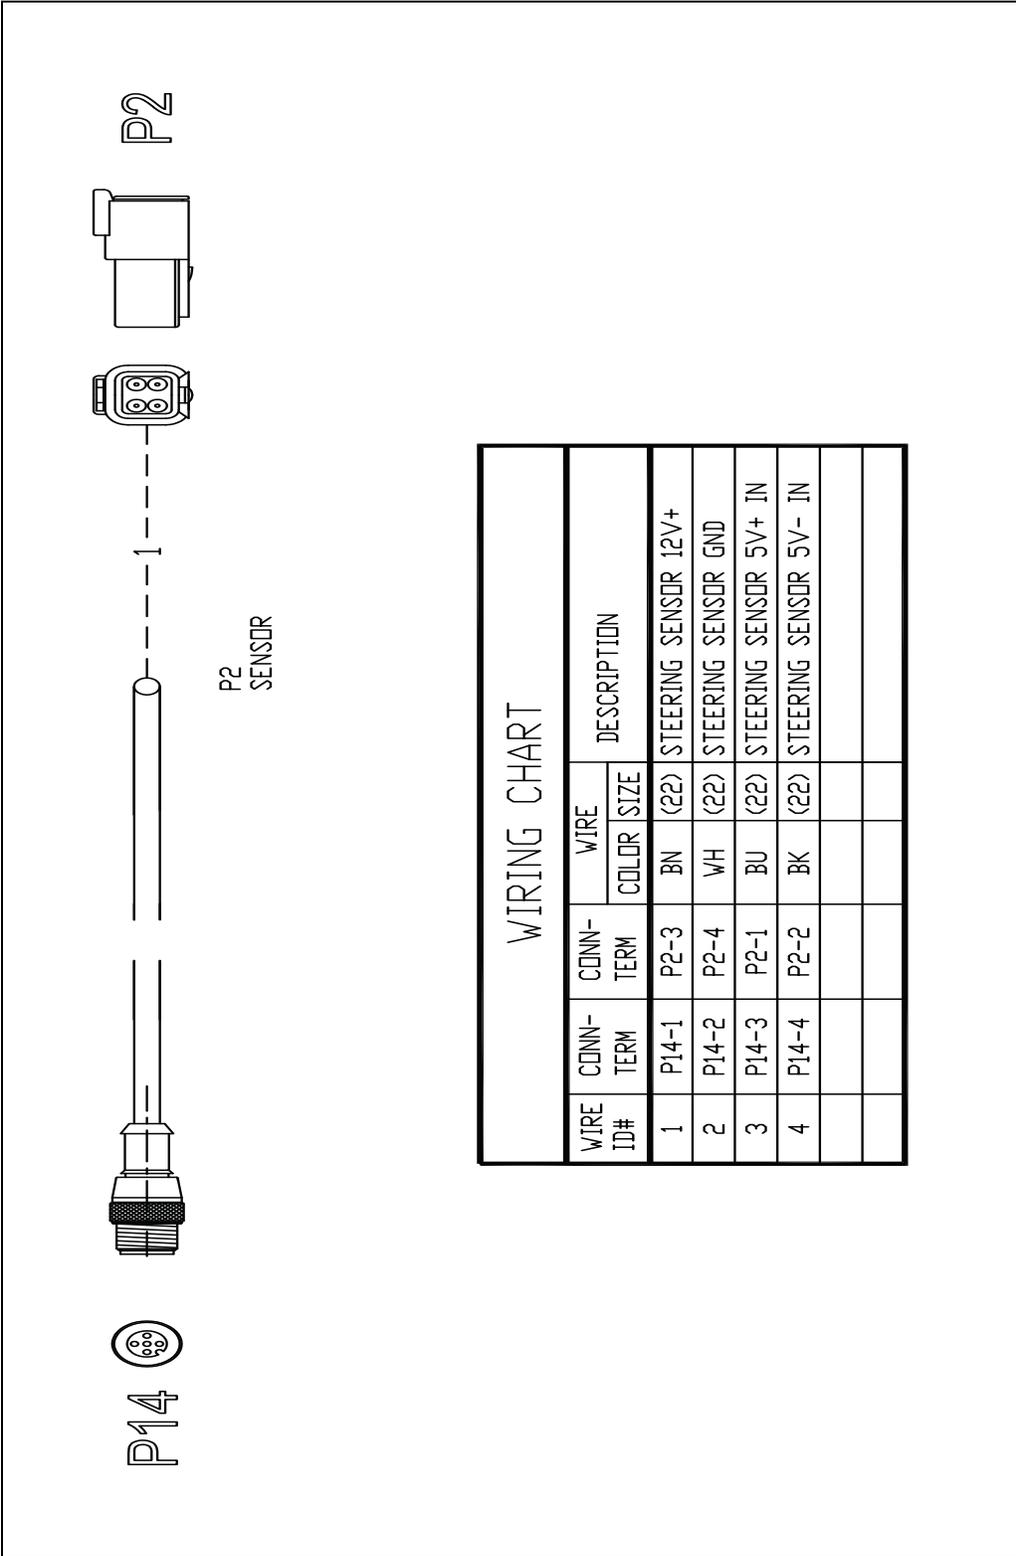
AutoSense device harness: P/N 57560

WIRE ID#	CONN-TERM	CONN-TERM	WIRE		DESCRIPTION
			COLOR	SIZE	
1	P14-1	P2-3	BN	(22)	STEERING SENSOR 12V+
2	P14-2	P2-4	WH	(22)	STEERING SENSOR GND
3	P14-3	P2-1	BU	(22)	STEERING SENSOR 5V+ IN
4	P14-4	P2-2	BK	(22)	STEERING SENSOR 5V- IN

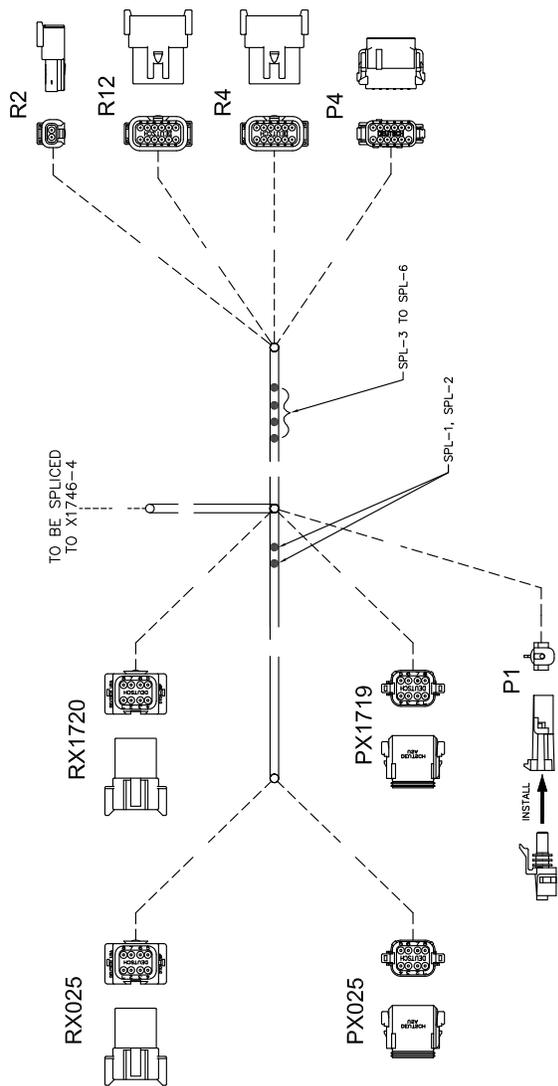
Fend 700/800 Fendt CAN interface: P/N 65548

CONNECTOR CHART-REFERENCE			
CONN-TERM	WIRE ID#	COLOR	DESCRIPTION
R4-1	11C	YW	CAN_H ISO
R4-2	18	OR	THRU
R4-3	19	BU	THRU
R4-4	20	BR	THRU
R4-10	21	BR	THRU
R4-11	22	WH	THRU
R4-12	10C	GN	CAN_L ISO
RX1720-1	1A	RD	+12V BAT
RX1720-2	5	OR	THRU
RX1720-3	2A	BK	GROUND
RX1720-4	6	BU	THRU
RX1720-5	7	YW	CAN_H V
RX1720-6	8	BR	CAN_L V
RX1720-7	7	BR	THRU
RX1720-8	8	PK	THRU
RX025-1	10A	GN	CAN_L ISO
RX025-2	12	OR	THRU
RX025-3	13	BU	THRU
RX025-4	14	BR	THRU
RX025-5	15	PK	THRU
RX025-6	16	WH	THRU
RX025-7	17	GY	THRU
RX025-8	11A	YW	CAN_H ISO
R12-1	4C	GN	CAN_L V
R12-12	3C	GN	CAN_L V
X1746-4	9	RD/WH	SW POWER
SPL-1	1A	RD	+12V BAT
SPL-2	1A	BR	GROUND
SPL-3	4A	YW	CAN_H V
SPL-4	3A	GN	CAN_L V
SPL-5	10A	GN	CAN_L ISO
SPL-6	11A	YW	CAN_H ISO

CONNECTOR CHART-REFERENCE			
CONN-TERM	WIRE ID#	COLOR	DESCRIPTION
P1-1	1B	RD	+12V BAT
P4-2	18	OR	THRU
P4-3	19	BU	THRU
P4-4	20	BR	THRU
P4-10	21	BR	THRU
P4-11	22	WH	THRU
PX1719-1	1C	RD	+12V BAT
PX1719-2	5	OR	THRU
PX1719-3	2B	BK	GROUND
PX1719-4	6	BU	THRU
PX1719-5	7	YW	CAN_H V
PX1719-6	8	BR	CAN_L V
PX1719-7	7	BR	THRU
PX1719-8	8	PK	THRU
PX025-1	10B	GN	CAN_L ISO
PX025-2	12	OR	THRU
PX025-3	13	BU	THRU
PX025-4	14	BR	THRU
PX025-5	15	PK	THRU
PX025-6	16	WH	THRU
PX025-7	17	GY	THRU
PX025-8	11B	YW	CAN_H ISO
R2-1	2C	BK	GROUND
R2-2	9	RD/WH	SW POWER

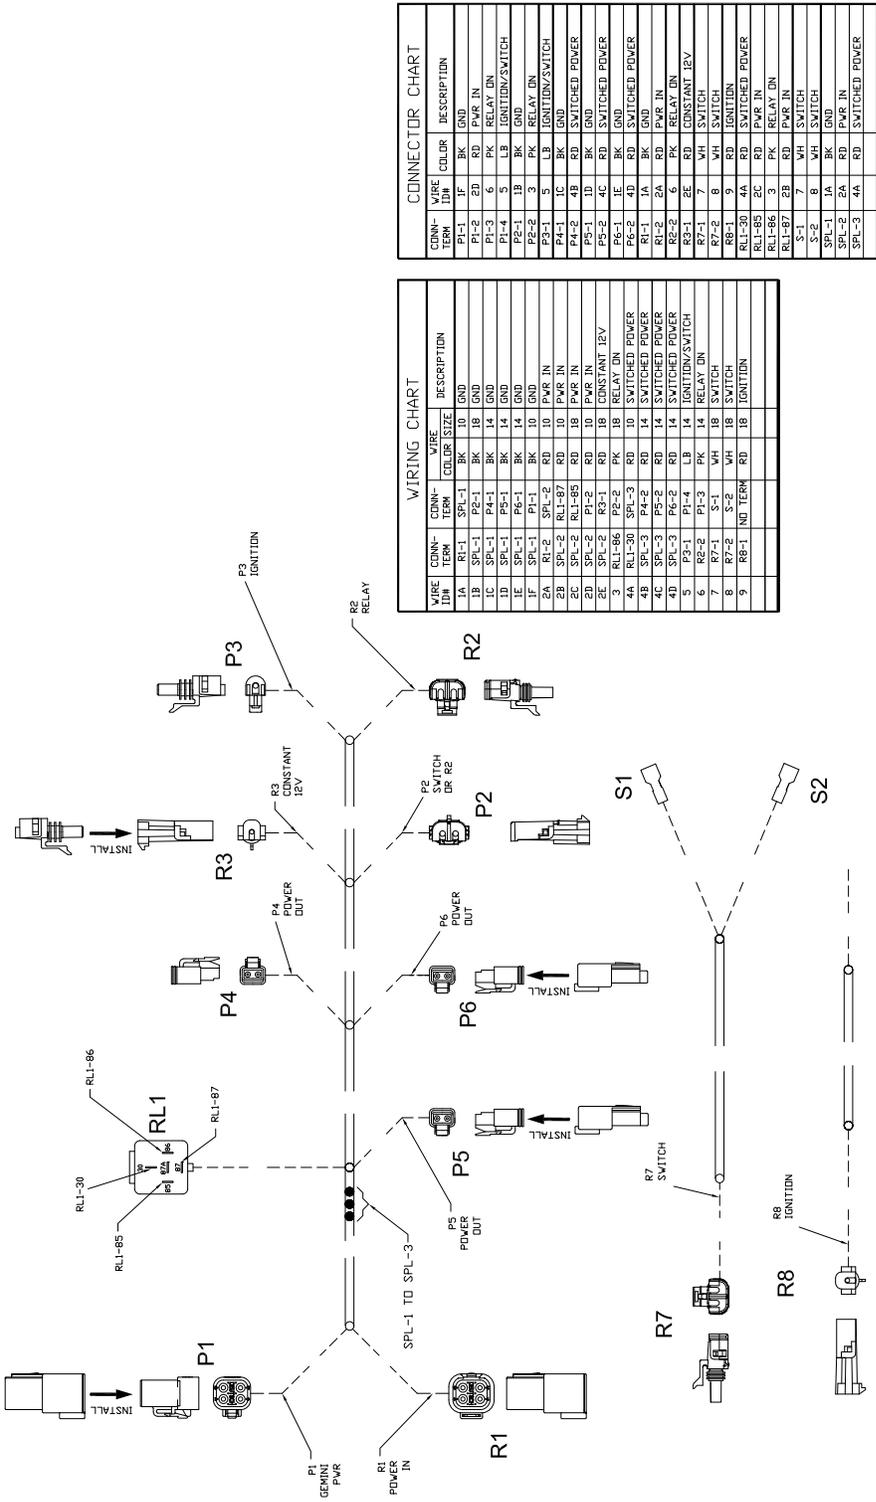
CFX-750/FmX display power buss harness with relay and switch: P/N 67295

CONN-TERM	WIRE COLOR	DESCRIPTION
P1-1	1F	BK GND
P1-2	2D	RD PMR IN
P1-3	6	PK RELAY DN
P1-4	5	LB IGNITION/SWITCH
PE-1	1B	BK GND
PE-2	3	PK RELAY DN
PE-3	1B	BK GND
PE-4	1C	RD IGNITION/SWITCH
P4-1	4B	RD SWITCHED POWER
P5-1	1D	BK GND
P5-2	4C	RD SWITCHED POWER
P6-1	1E	BK GND
P6-2	4D	RD SWITCHED POWER
R1-1	1A	BK GND
R1-2	2A	RD PMR IN
R1-3	2E	RD PMR IN
R2-1	8E	PK CONSTANT 12V
R7-1	7	VH SWITCH
R7-2	8	VH SWITCH
R8-1	9	RD IGNITION
RL1-30	4A	RD SWITCHED POWER
RL1-85	5C	RD RELAY DN
RL1-86	2B	RD SWITCHED POWER
RL1-87	2B	RD SWITCHED POWER
S-1	8	VH SWITCH
S-2	8	VH SWITCH
SPL-1	1A	BK GND
SPL-2	2A	RD PMR IN
SPL-3	4A	RD SWITCHED POWER

CONN-TERM	WIRE COLOR	WIRE SIZE	DESCRIPTION
1A	RI-1	BK 18	GND
1B	SPL-1	BK 18	GND
1C	P4-1	BK 14	GND
1D	SPL-1	BK 14	GND
1E	P6-1	BK 14	GND
1F	SPL-1	BK 10	GND
2A	SPL-2	RD 18	PMR IN
2B	SPL-2	RD 18	PMR IN
2C	SPL-2	RD 18	PMR IN
2D	SPL-2	RD 18	PMR IN
2E	SPL-2	RD 18	CONSTANT 12V
3	RL1-86	PK 18	RELAY DN
4A	RL1-30	RD 18	SWITCHED POWER
4B	SPL-3	RD 14	SWITCHED POWER
4C	SPL-3	RD 14	SWITCHED POWER
4D	SPL-3	RD 14	SWITCHED POWER
5	P3-1	LB 14	IGNITION/SWITCH
6	R2-2	PK 14	RELAY DN
7	R7-1	S-1	VH SWITCH
8	R7-2	S-2	VH SWITCH
9	R8-1	ND TERM	RD 18 IGNITION

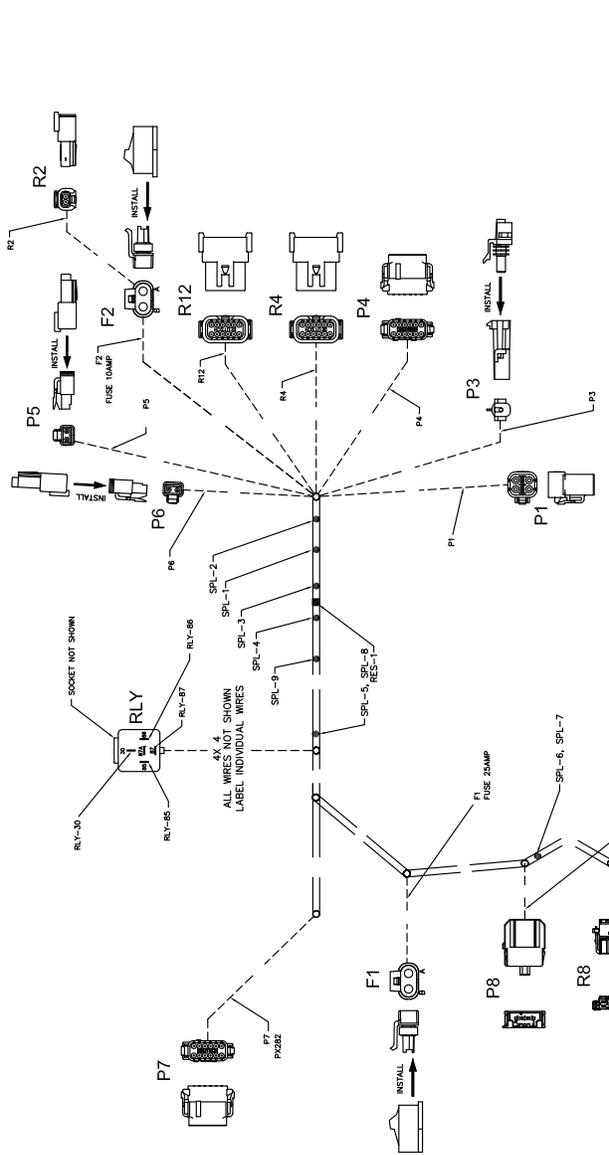
Challenger MT and MF Autopilot CAN interface cable: P/N 77644

CONN. TERM	WIRE	COLOR	DESCRIPTION
SPL-1	2A	OR	CAN L ISO
SPL-1	2B	OR	CAN L ISO
SPL-2	3A	OR	CAN H ISO
SPL-2	3B	OR	CAN H ISO
SPL-3	4A	OR	CAN L ISO
SPL-3	4B	OR	CAN L ISO
SPL-4	5A	OR	CAN H ISO
SPL-4	5B	OR	CAN H ISO
SPL-5	6A	OR	CAN L ISO
SPL-5	6B	OR	CAN L ISO
SPL-6	7A	OR	CAN H ISO
SPL-6	7B	OR	CAN H ISO
SPL-7	8A	OR	CAN L ISO
SPL-7	8B	OR	CAN L ISO
SPL-8	9A	OR	CAN H ISO
SPL-8	9B	OR	CAN H ISO

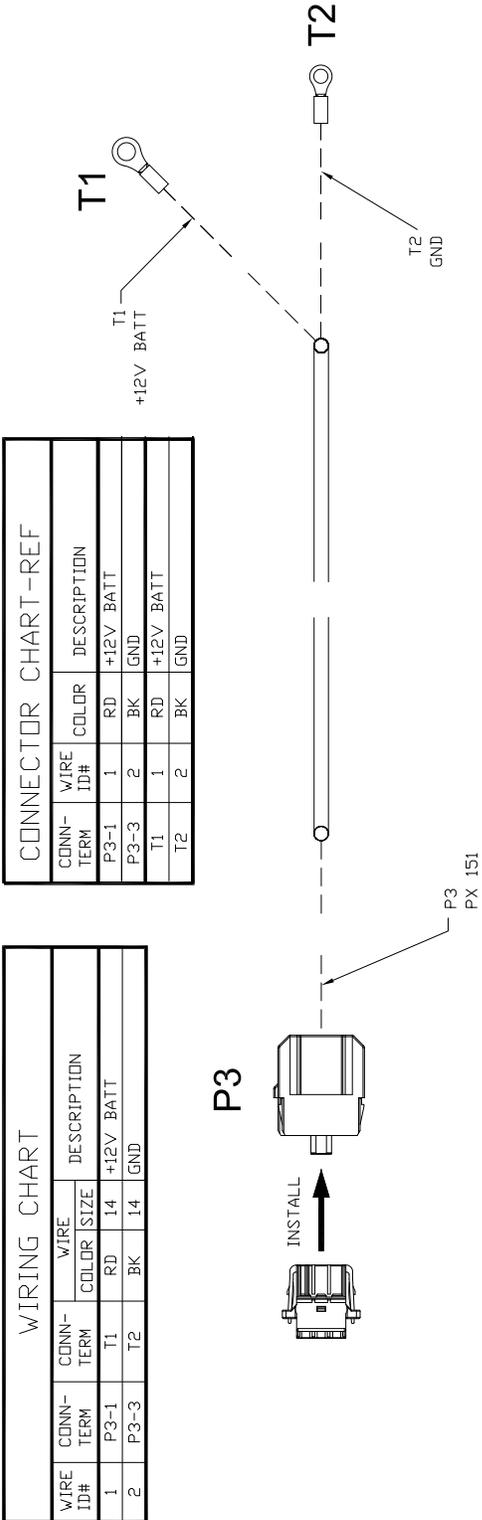
Challenger MT and MF 3-pin power adapter: P/N 77646

CONN-TERM	WIRE ID#	COLOR	DESCRIPTION
P3-1	1	RD	+12V_BATT
P3-3	2	BK	GND
T1	1	RD	+12V_BATT
T2	2	BK	GND

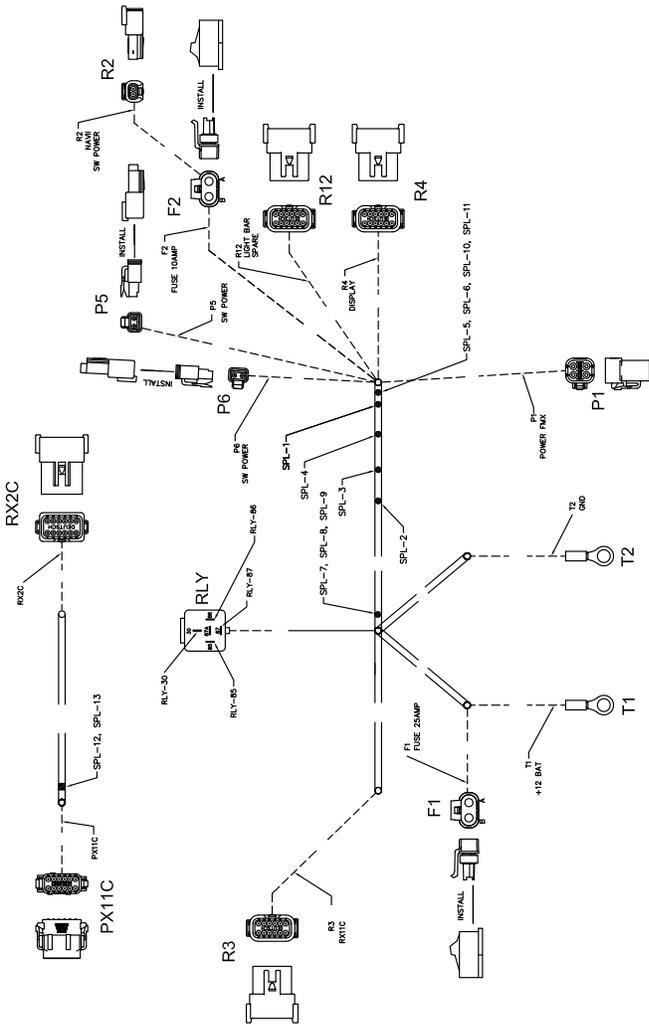
Valtra T Series CAN interface: P/N 82681

CONN- ID#	WIRE COLOR	DESCRIPTION
REL-30	RD	12V SW
REL-85	RD	12V SW
REL-86	RD	12V SW
REL-87	RD	12V SW
SPL-1	RD	12V SW
SPL-2	RD	12V SW
SPL-3	RD	12V SW
SPL-4	RD	12V SW
SPL-5	RD	12V SW
SPL-6	RD	12V SW
SPL-7	RD	12V SW
SPL-8	RD	12V SW
SPL-9	RD	12V SW
SPL-10	RD	12V SW
SPL-11	RD	12V SW

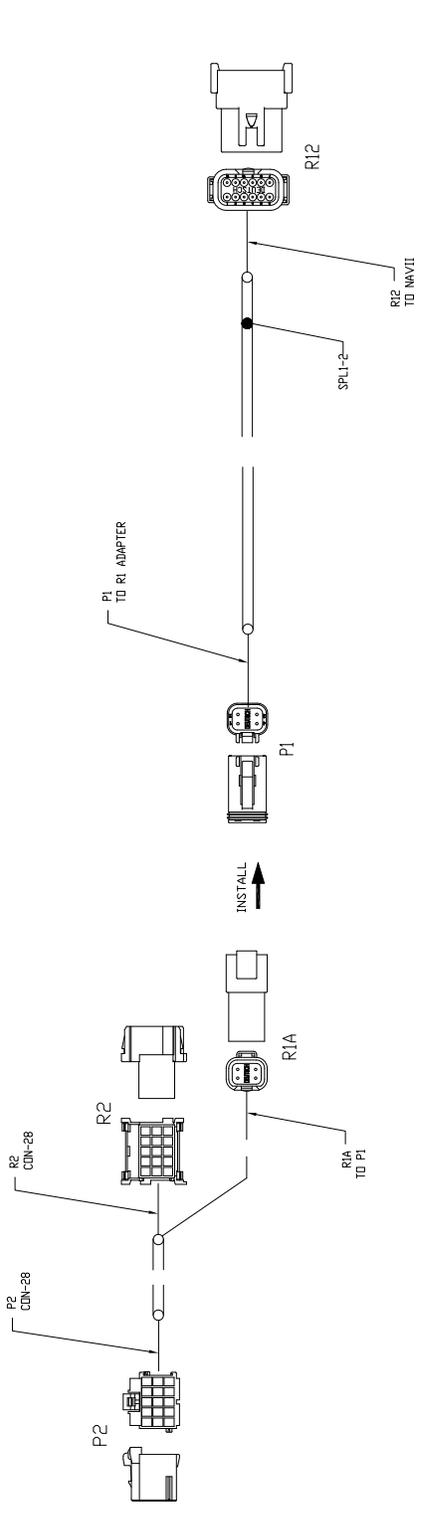
Cable Assy, AGCO CAN interface - MF7000, MF7100, Valtra BT; MF9030, Valtra BS 3020H: P/N 84796

CONNECTOR CHART - REFERENCE				CONNECTOR CHART - REFERENCE			
CONN-TERM	WIRE ID#	COLOR	DESCRIPTION	CONN-TERM	WIRE ID#	COLOR	DESCRIPTION
P1-1	41A	GN	CAN L TRUNK	R1B-1	24	GN	CAN L TRUNK
P1-2	42A	YM	CAN H TRUNK	R1B-2	25	YM	CAN H TRUNK
P1-3	41B	GN	CAN L TRUNK	R1B-3	26	GN	CAN L TRUNK
P1-4	42B	YM	CAN H TRUNK	R1B-4	27	YM	CAN H TRUNK
P2-1	1	GY	THRU	R2-1	1	GY	THRU
P2-2	2	GY	THRU	R2-2	2	GY	THRU
P2-3	3	GY	THRU	R2-3	3	GY	THRU
P2-4	4	GN	CAN L TRUNK	R2-4	6	GN	CAN L TRUNK
P2-5	5	YM	CAN H TRUNK	R2-5	7	YM	CAN H TRUNK
P2-6	8	GY	THRU	R2-6	8	GY	THRU
P2-7	9	GY	THRU	R2-7	9	GY	THRU
P2-8	10	GY	THRU	R2-8	10	GY	THRU
P2-9	11	GY	THRU	R2-9	11	GY	THRU
P2-10	12	GY	THRU	R2-10	12	GY	THRU
P2-11	13	GY	THRU	R2-11	13	GY	THRU
P2-12	14	GY	THRU	R2-12	14	GY	THRU
P2-13	15	GY	THRU	R2-13	15	GY	THRU
P2-14	16	GY	THRU	R2-14	16	GY	THRU
P3-1	21	GY	THRU	R3-1	21	GY	THRU
P3-2	22	GY	THRU	R3-2	22	GY	THRU
P3-3	23	GY	THRU	R3-3	23	GY	THRU
P3-4	24	GN	CAN L TRUNK	R3-4	25	GN	CAN L TRUNK

P3-5	25	YM	CAN H TRUNK	R3-5	27	YM	CAN H TRUNK
P3-6	28	GY	THRU	R3-6	28	GY	THRU
P3-7	29	GY	THRU	R3-7	29	GY	THRU
P3-8	30	GY	THRU	R3-8	30	GY	THRU
P3-9	31	GY	THRU	R3-9	31	GY	THRU
P3-10	32	GY	THRU	R3-10	32	GY	THRU
P1A-1	4	GN	CAN L TRUNK	R1E-1	42C	YM	CAN H BRANCH
P1A-2	5	YM	CAN H TRUNK	R1E-2	41C	GN	CAN L BRANCH
P1A-3	6	GN	CAN L TRUNK				
P1A-4	7	YM	CAN H TRUNK
