Autopilot

AUTOMATED STEERING SYSTEM

Version 4.00
Revision A
September 2016

This is the October 2016 release (Revision A) of the *Autopilot Automated Steering System Troubleshooting Guide*. It applies to version 4.00 of the NextSwath Vehicle Integration End-of-Row Turn Technology.

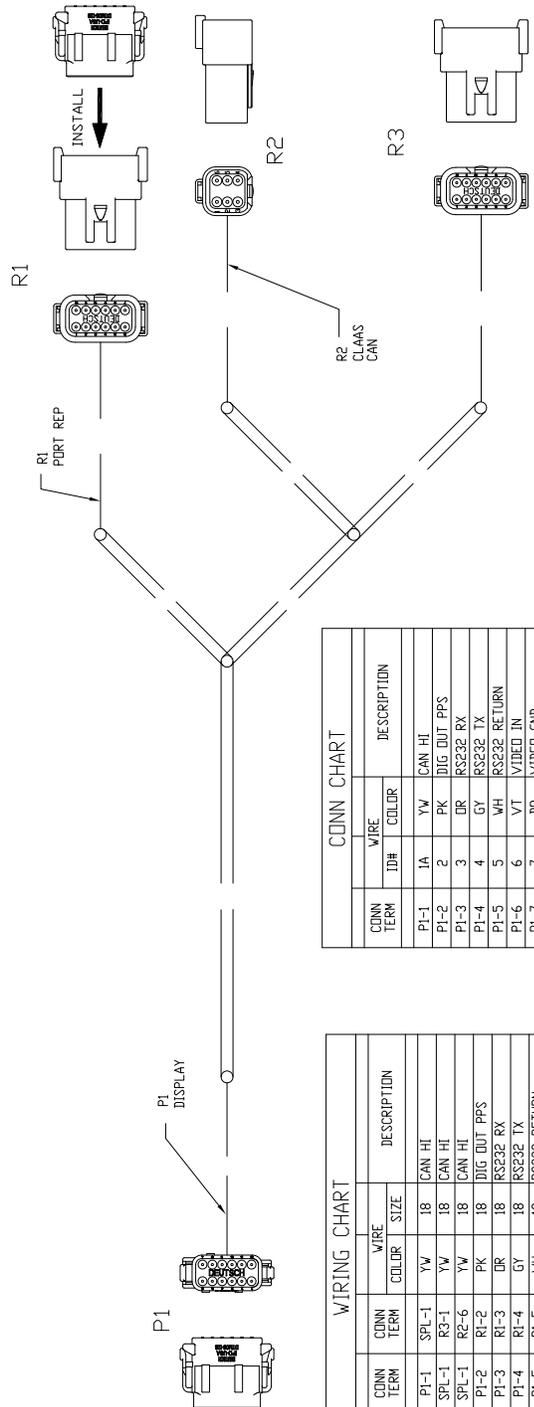
Claas Lexion and Jaguar AP and YM over CAN cable: P/N 85791'

CONN TERM	WIRE		DESCRIPTION
	ID#	COLOR	
PI-1	1A	YW	CAN HI
PI-2	2	PK	DIG OUT PPS
PI-3	3	DR	RS232 TX
PI-4	4	GY	RS232 TX
PI-5	5	WH	RS232 RETURN
PI-6	6	VT	VIDEO IN
PI-7	7	BR	VIDEO GND
PI-8	8	BK/WH	POWER GND
PI-9	9	RD/WH	UNREG V+ DUT
PI-10	10	TN	DIGITAL GND
PI-11	11	BU	DIG/ANLG IN
PI-12	12A	GN	CAN LO
RI-2	2	PK	DIG OUT PPS
RI-3	3	DR	RS232 RX
RI-4	4	GY	RS232 TX
RI-5	5	WH	RS232 RETURN
RI-6	6	VT	VIDEO IN
RI-7	7	BR	VIDEO GND
RI-8	8	BK/WH	POWER GND
RI-9	9	RD/WH	UNREG V+ DUT
RI-10	10	TN	DIGITAL GND
RI-11	11	BU	DIG/ANLG IN
RI-12	12C	GN	CAN LO
RI-13	12B	GN	CAN LO
RI-14	12A	GN	CAN LO
SPI-1	1A	YW	CAN HI
SPI-2	12A	GN	CAN LO

WIRE ID#	CONN TERM	WIRE		DESCRIPTION
		COLOR	SIZE	
1A	PI-1	YW	18	CAN HI
1B	R3-1	YW	18	CAN HI
1C	SPL-1	YW	18	CAN HI
2	PI-2	PK	18	DIG OUT PPS
3	PI-3	DR	18	RS232 TX
4	PI-4	GY	18	RS232 TX
5	PI-5	WH	18	RS232 RETURN
6	PI-6	VT	18	VIDEO IN
7	PI-7	BR	18	VIDEO GND
8	PI-8	BK/WH	18	POWER GND
9	PI-9	RD/WH	18	UNREG V+ DUT
10	PI-10	TN	18	DIGITAL GND
11	PI-11	BU	18	DIG/ANLG IN
12A	SPL-4	GN	18	CAN LO
12B	R3-4	GN	18	CAN LO
12C	SPL-4	GN	18	CAN LO

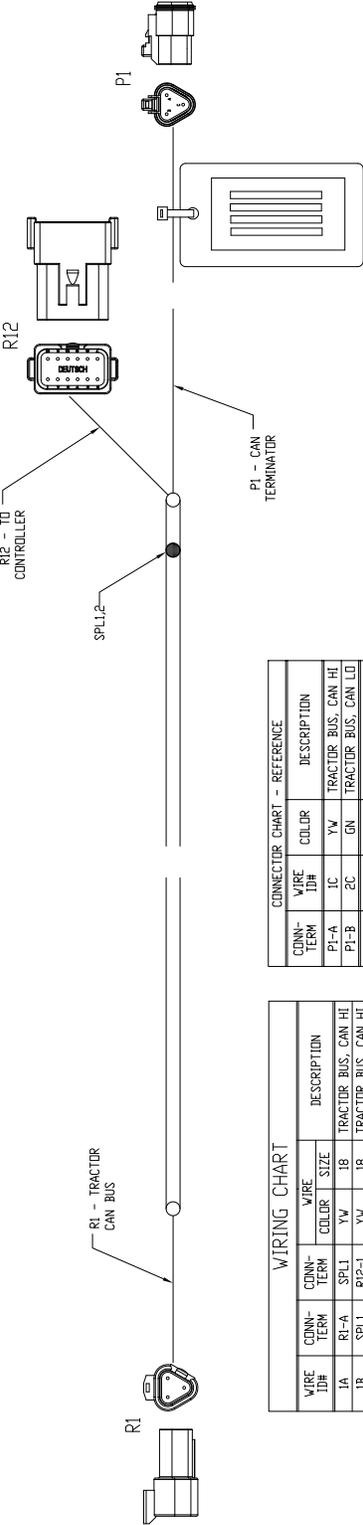
AGCO CAN combines: P/N 90324

CONN-TERM	WIRE ID#	COLOR	DESCRIPTION
P1-A	1C	YW	TRACTOR BUS, CAN HI
P1-B	2C	GN	TRACTOR BUS, CAN LO
R1-A	1A	YW	TRACTOR BUS, CAN HI
R1-B	2A	GN	TRACTOR BUS, CAN LO
R12-1	1B	YW	TRACTOR BUS, CAN HI
R12-12	2B	GN	TRACTOR BUS, CAN LO

WIRE ID#	CONN-TERM	WIRE		DESCRIPTION
		COLOR	SIZE	
1A	R1-A	YW	18	TRACTOR BUS, CAN HI
1B	SPL1	YW	18	TRACTOR BUS, CAN HI
1C	R12-1	YW	18	TRACTOR BUS, CAN HI
2A	SPL1	GN	18	TRACTOR BUS, CAN LO
2B	R1-B	GN	18	TRACTOR BUS, CAN LO
2C	SPL2	GN	18	TRACTOR BUS, CAN LO
	P1-B	GN	18	TRACTOR BUS, CAN LO

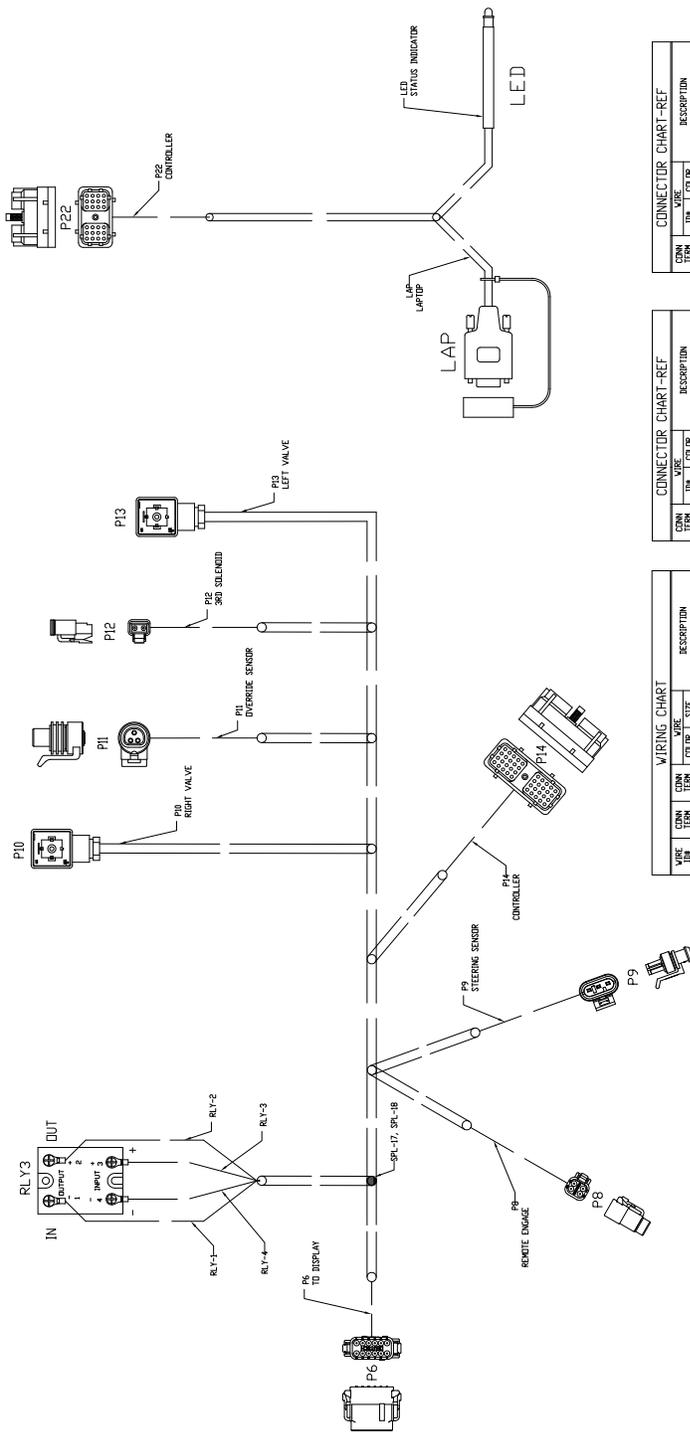
MacDon Factory Ready Interface: P/N 93353

CONN	WIRE	COLOR	DESCRIPTION
P22-1	65	BR/WH	BATT. BIT
P22-2	66	RD/WH	AP DIAG RES22 TX
P22-3	67	OR	AP DIAG RES22 RX
P22-4	68	VM	AP DIAG RES22 GND
P22-19	64	BR	STATUS LED
RLY-3-1	53	RD	PWR-BATT. LEV
RLY-3-2	54	OR	MANUAL OVERRIE GND
RLY-3-3	55	OR	MANUAL OVERRIE SV IN
RLY-3-4	41	RD	DIS. OUT
LAP-1	55	BR/WH	BATT. BIT
LAP-2	56	OR	AP DIAG RES22 TX
LAP-3	57	OR	AP DIAG RES22 RX
LAP-4	58	VM	AP DIAG RES22 GND
LAP-5	69	VM	AP DIAG RES22 GND
LAP-6	63	OR	STATUS LED
LAP-7	64	OR	STATUS LED
SP-17	59A	RD	BATT. PWR
SP-18	59A	BR	BATT. PWR

CONN	WIRE	COLOR	DESCRIPTION
P4-1	50	VM	STEERING SENSOR GND
P4-2	51	RD	DISP. AT PWR.
P4-3	52	OR	STEERING SENSOR SV IN
P4-4	53	OR	VALVE DRIVE COIL A V+
P4-5	60	ON	VALVE DRIVE COIL B V+
P4-6	54	ON	MANUAL OVERRIE GND
P4-7	55	RD/WH	MANUAL OVERRIE SV IN
P4-8	56	OR	BATT. GND
P4-9	57	OR	REWRITE ENGAGE EV IN
P4-10	58	OR	REWRITE ENGAGE EV IN
P4-11	59	OR	VALVE DRIVE COIL A V+
P4-12	59	OR	VALVE DRIVE COIL A V+
P4-13	59	OR	VALVE DRIVE COIL A V+
P4-14	59	OR	VALVE DRIVE COIL A V+
P4-15	59	OR	VALVE DRIVE COIL A V+
P4-16	59	OR	VALVE DRIVE COIL A V+
P4-17	59	OR	VALVE DRIVE COIL A V+
P4-18	59	OR	VALVE DRIVE COIL A V+
P4-19	59	OR	VALVE DRIVE COIL A V+
P4-20	59	OR	VALVE DRIVE COIL A V+
P4-21	59	OR	VALVE DRIVE COIL A V+
P4-22	59	OR	VALVE DRIVE COIL A V+
P4-23	59	OR	VALVE DRIVE COIL A V+
P4-24	59	OR	VALVE DRIVE COIL A V+
P4-25	59	OR	VALVE DRIVE COIL A V+
P4-26	59	OR	VALVE DRIVE COIL A V+
P4-27	59	OR	VALVE DRIVE COIL A V+
P4-28	59	OR	VALVE DRIVE COIL A V+

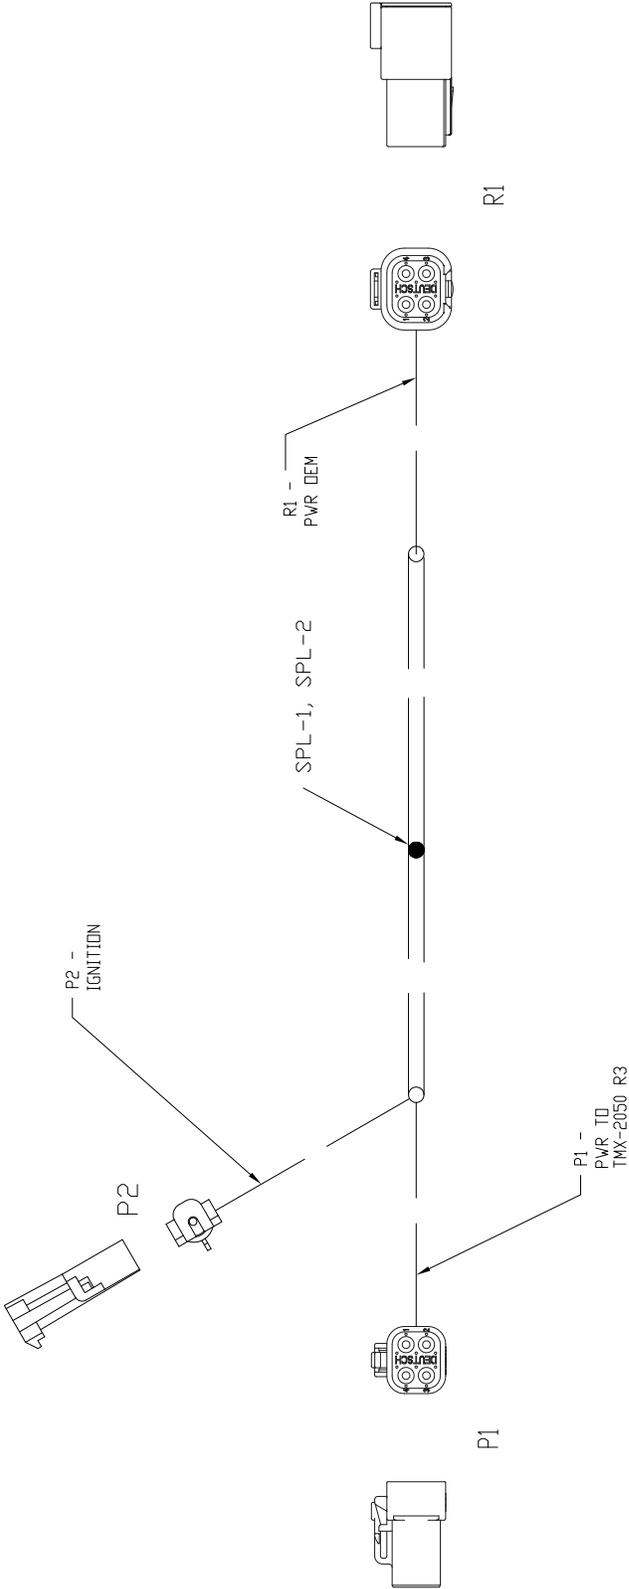
OEM power to TMX-2050 power adapter: P/N 95918

CONN TERM	WIRE		DESCRIPTION
	ID#	COLOR	
R1-1	3A	BK	-BATT
R1-2	2A	RD	+BATT
R1-4	1	RD	IGNITION
P2-1	1	RD	IGNITION
P1-1	3B	BK	-BATT
P1-2	2B	RD	+BATT
P1-3	3C	BK	-BATT
P1-4	2C	RD	+BATT
SPL-1	2A	RD	+BATT
SPL-2	3A	BK	-BATT

WIRE ID#	CONN TERM	WIRE		DESCRIPTION
		COLOR	SIZE	
1	R1-4	RD	14	IGNITION
2A	R1-2	RD	10	+BATT
2B	SPL-1	RD	12	+BATT
2C	SPL-1	RD	12	+BATT
3A	R1-1	BK	10	-BATT
3B	SPL-2	BK	12	-BATT
3C	SPL-2	BK	12	-BATT

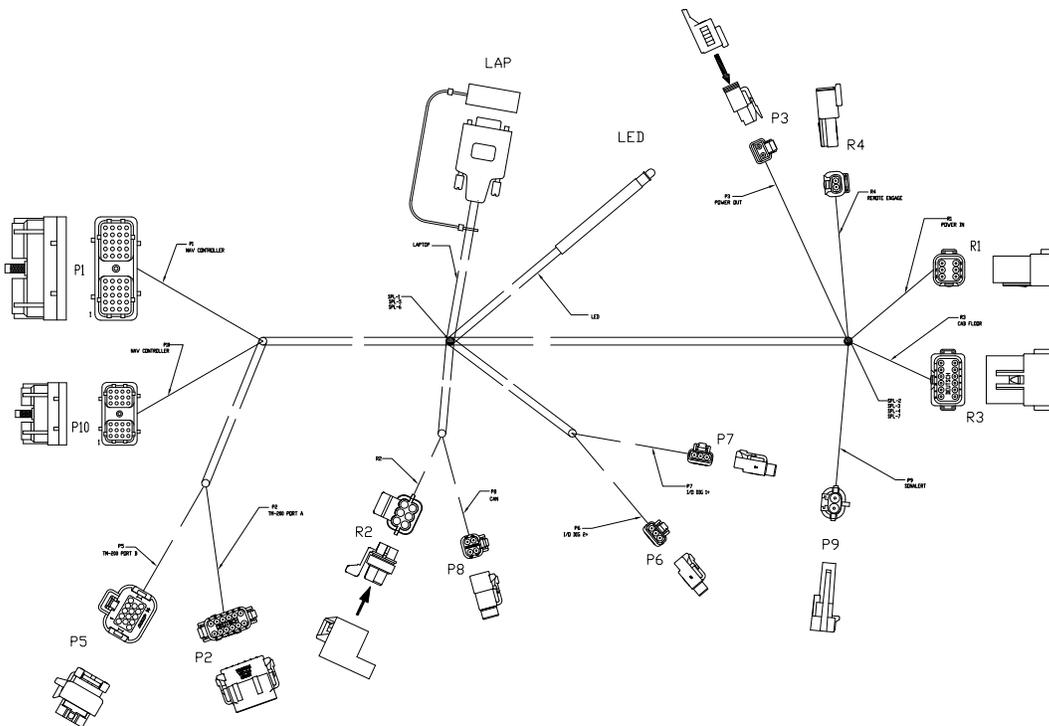
Main Autopilot, NavController II / TMX-2050 display in-cab, Versatile: P/N 103038

WIRE ID#	CONN TERM	CONN TERM	WIRE COLOR	SIZE	DESCRIPTION
1A	R1-1	SPL-7	RD	14	12V SA MACHINE POWER
1B	SPL-7	P5-1	RD	16	12V SA POWER TO TM-200
1C	SPL-7	P3-2	RD	14	12V SA AUX. POWER
2	R1-2	P5-2	RD	16	12V 10A POWER TO TM-200
3	P1-1	P5-5	RD	18	POWER TO NAV
4	P5-3	R2-1	RD	18	12V I/O
5	P5-4	P7-1	BR	18	DIG+
7A	P5-7	SPL-1	Y/W	20	CAN HI 1
7B	SPL-1	R2-2	Y/W	20	CAN HI 1
7C	SPL-1	P6-2	Y/W	20	CAN HI 1
8A	P5-8	SPL-6	GN	20	CAN LD 1
8B	SPL-6	R2-6	GN	20	CAN LD 1
8C	SPL-6	P6-4	GN	20	CAN LD 1
9A	P1-1	SPL-2	GN	18	GND
9B	SPL-2	R1-5	BK	14	GND
9C	SPL-2	R1-6	BK	18	GND
9D	SPL-2	P3-1	BK	14	GND
9E	SPL-2	P5-10	BK	18	GND
9F	SPL-2	P5-11	BK	18	GND
9G	SPL-2	P5-14	BK	18	GND
10	P5-13	P6-1	VT	18	DIGI
11A	P1-6	SPL-3	DR	18	AUTO STEER ENABLE
11B	SPL-3	R1-4	DR	18	AUTO STEER ENABLE
11C	SPL-3	R4-1	DR	18	REMOTE ENGAGE
12	P1-18	R3-1	BR	18	STEERING SENSOR SV+ IN
13	P1-28	R3-2	RD/WH	18	STEERING SENSOR SV- IN
14	P10-16	R3-3	DR	18	STEERING SENSOR +12V
15	P1-9	R3-4	Y/W	18	STEERING SENSOR GND

CONN TERM	ID#	CONN	WIRE DESCRIPTION
SPL-1	7A	P5-7	CAN HI 1
	7B	R2-E	
	7C	P8-2	
SPL-2	9A	P1-1	GND
	9B	R1-5	
	9C	R1-6	
	9D	P3-1	
	9E	P5-10	
	9F	P5-11	
	9G	P5-14	
SPL-3	11A	P1-6	AUTO STEER ENABLE
	11B	R1-4	
	11C	R4-1	
SPL-4	37A	P1-27	+5V OUT (SPARE)
	37B	R3-11	
	37C	R4-2	
SPL-5	38A	P5-9	GND J
	38B	P6-2	
	38C	P7-2	
SPL-6	8A	P5-8	CAN LD 1
	8B	P8-4	
SPL-7	1A	R1-1	12V SA MACHINE POWER
	1B	P5-1	12V SA POWER TO TM-200
	1C	P3-2	12V SA AUX. POWER

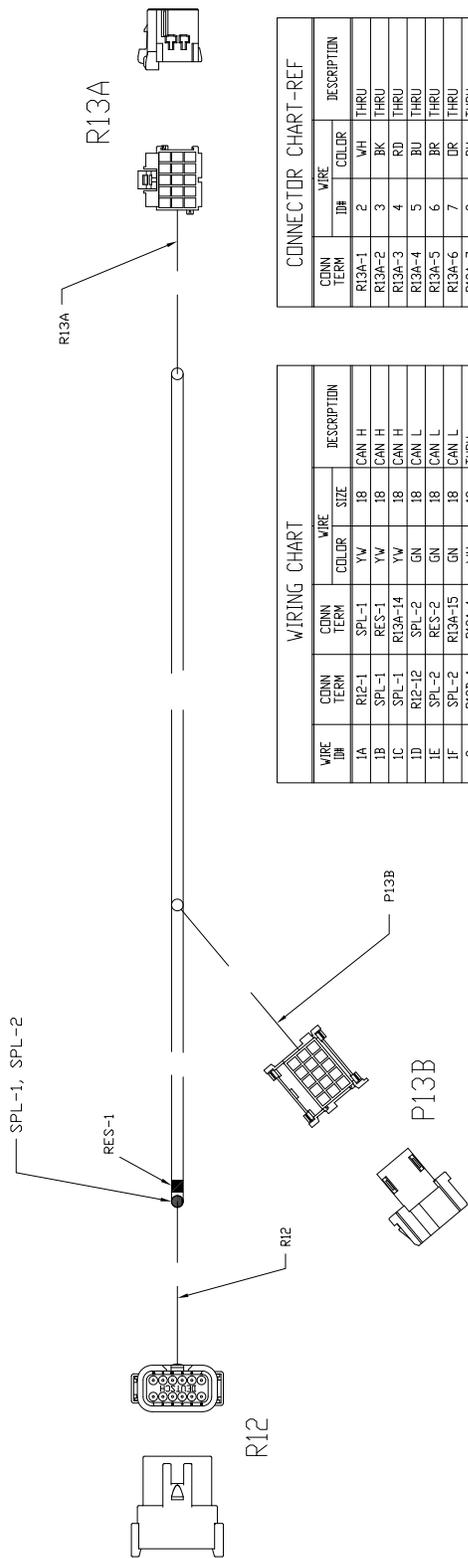
CAN Interface, Amazone Pantera: P/N 104492

WIRE ID#	CONN TERM	CONN TERM	WIRE			DESCRIPTION
			COLOR	SIZE	DESCRIPTION	
1A	R12-1	SPL-1	YW	18	CAN H	
1B	R12-1	RES-1	YW	18	CAN H	
1C	R12-1	SPL-1	YW	18	CAN H	
1D	R12-1	SPL-2	GN	18	CAN L	
1E	R12-1	RES-2	GN	18	CAN L	
2	R12-2	R13A-15	GN	18	CAN L	
3	P13B-1	R13A-1	VH	18	THRU	
4	P13B-2	R13A-2	BK	18	THRU	
5	P13B-3	R13A-3	RD	18	THRU	
6	P13B-4	R13A-4	BU	18	THRU	
7	P13B-5	R13A-5	BR	18	THRU	
8	P13B-6	R13A-6	DR	18	THRU	
9	P13B-7	R13A-7	PU	18	THRU	
10	P13B-8	R13A-8	GY	18	THRU	
11	P13B-9	R13A-9	BU	18	THRU	
12	P13B-10	R13A-10	BR	18	THRU	
13	P13B-11	R13A-11	DR	18	THRU	
14	P13B-12	R13A-12	BK/WH	18	THRU	
	P13B-13	R13A-13	RD/WH	18	THRU

CONNECTOR CHART-REF		
CONN TERM	WIRE	DESCRIPTION
P15	16A	RD/WH IGNITION ON
P6-1	23	VT DIG 1+
P6-2	31B	BU GND J
P7-1	19	BR DIG 2+
P7-2	31C	BU GND J
P8-1	24	RD 12V+ TBC
P8-2	20C	YW CAN HI 1
P8-3	25	BK GND TBC
P8-4	21C	GN CAN LD 1
P9-A	32	WH SDNALERT V+
P9-B	33	GY SDNALERT GND
P11-1	4	PU REMOTE ENGAGE 12+
P11-2	5	BR REMOTE ENGAGE GND
P11-3	16E	RD IGNITION ON
P12-2	34	YW CAN HI 1 TO NAV
P12-4	35	GN CAN LD 1 TO NAV
R1-1	22C	BK GND
R1-2	14A	RD POWER IN
R1-3	12A	BK GND
R1-4	13A	RD POWER IN
R15	15	RD/WH IGNITION ON
R2-A	18	RD I2 I/O
R2-B	24	RD 12V+ TBC
R2-C	30	BK 12V RETURN
R2-D	25	BK GND TBC
R2-E	20B	YW CAN HI 1
R2-F	21B	GN CAN LD 1
R4-2	16D	RD/WH IGNITION ON
R4-3	1	BK GND
R4-10	2	YW CAN2 HIGH
R4-11	3	GN CAN2 LOW
LAP-1	6	BK/WH BATT - DUT
LAP-2	7	RD/WH AP DIAG RS232 TX
LAP-3	8	DR AP DIAG RS232 RX
LAP-5	9	YW AP DIAG RS232 GND
LED-A	10	GY STATUS LED
LED-B	11	BR STATUS LED
SPL-1	22A	BK GND
SPL-2	14A	RD POWER IN
SPL-3	16A	RD/WH IGNITION ON
SPL-4	20A	GN CAN HI 1

SPL-5	21A	GN CAN LD 1
SPL-6	31A	BU GND J
SPL-7	12A	BK GND
SPL-8	13A	RD POWER IN
